## Appendix 2

### **Technical Briefing On The Condition Of The Former Hermitage Leisure Centre Building**

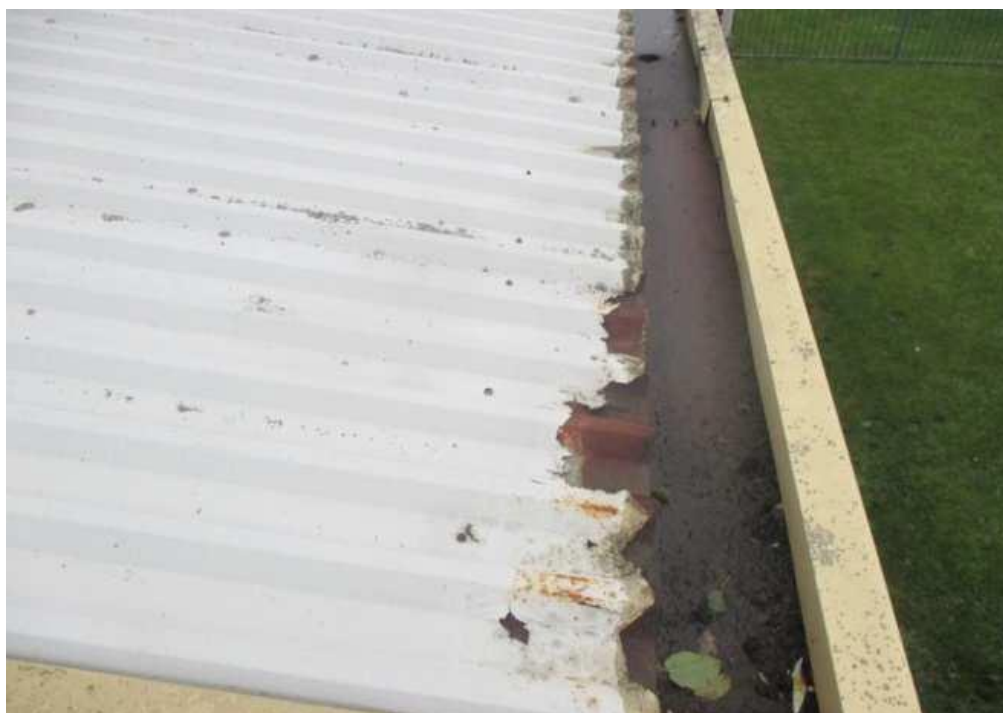
At HLC evidence of advanced corrosion of the edges of cladding panels can be observed. This gives rise to concern that fixing points may also be corroded and that panels could become detached in severe weather. This could only be disproved by a destructive survey involving the removal of areas of covering.

*“the profiled metal roof covering to the sports hall, gym and dryside changing area is in poor condition. The roof sheets date from original construction in 1987 and are over 34 years old. The lap and gutter edges are suffering from cut edge corrosion. The corrosion is progressive and can be problematic if it extends to the fixing bolts for the roof sheets, which is likely to happen in the medium term without treatment”.*

Corroded Edges to Cladding

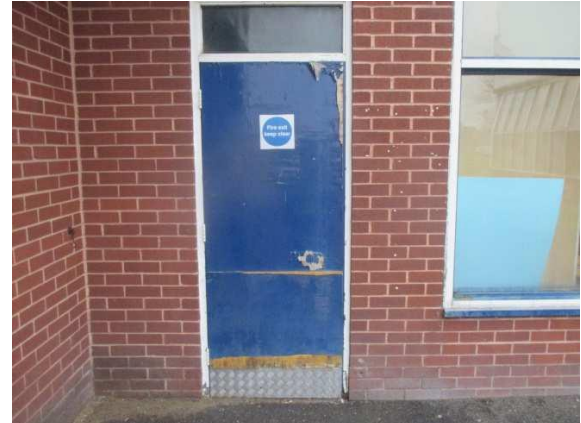
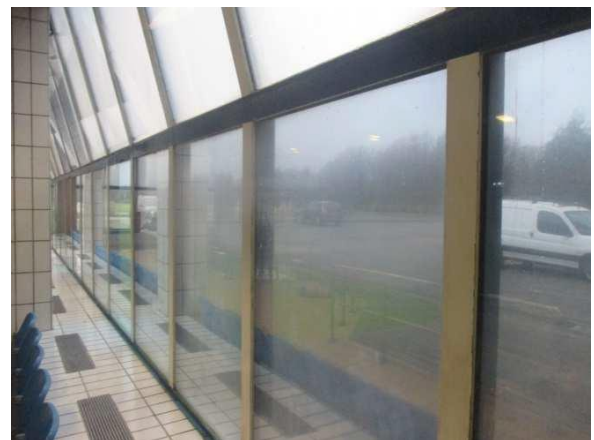
The most significant areas of building envelope failure are associated with the curtain walling. Almost all sections of curtain walling are exhibiting peeling of the protective coatings applied to the metal framework, whilst the seals on most glazing panels have also failed. The seals serve to keep an airtight gap between the two panes of glass in a double-glazed unit and to retain the glass unit in its surrounding frame. Seal failure is unsightly (the glass

Pictures above show failed window seals allowing misting of panels and poor condition of timber doors

*“ The glazed curtain walling to the rear and left elevations of the indoor swimming pool and front elevation plant room is in poor condition. The pre-finished powder coating has been overpainted with a non-compatible decorative finish which has failed and is peeling. The double-glazed units have comprehensively failed with condensation built up between the panes. Moss growth is also evident to the seals of windows. The curtain walling is beyond economical repair and requires wholesale replacement.”*

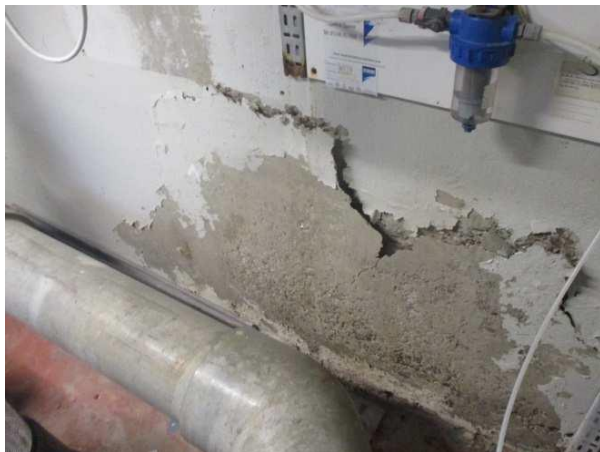
Left December 2021. Right August 2022

*“the concrete structure to the swimming pool is cracked and spalled in several areas most likely due to the high levels of humidity and chemical use”.*

*“large parts of the concrete basin itself have detached and are moving away from the main structure suggesting that the reinforcement steel is corroded and expanding”*

The above picture shows the Swimming Pool basin in the Plant Room. CBRE had concerns regarding the structural integrity of this area.

*“Given the extent of deterioration seen, we recommend that a package of concrete testing is undertaken to determine the condition of the concrete itself and embedded steelwork. The test results should be reviewed by a structural engineer and a package of remedial works undertaken prior to any proposed re- use being considered”.*

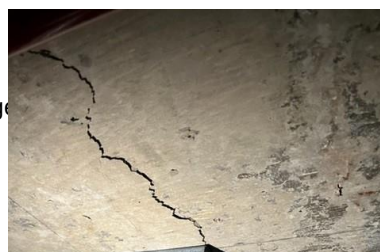
Structural Cracking To Pool Basin

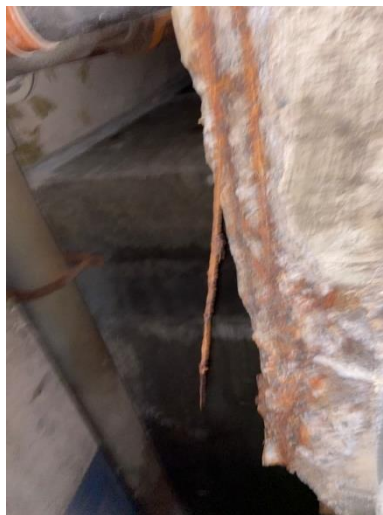
Corrosion of Reinforcement Within Structural Concrete

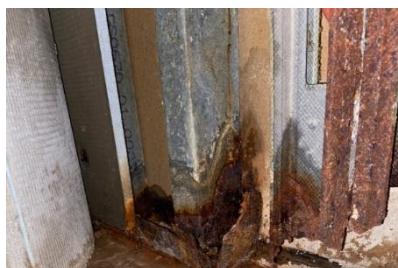
### Corrosion Of Steel Supports
