Appendix 2

Technical Briefing On The Condition Of The Former Hermitage Leisure Centre Building

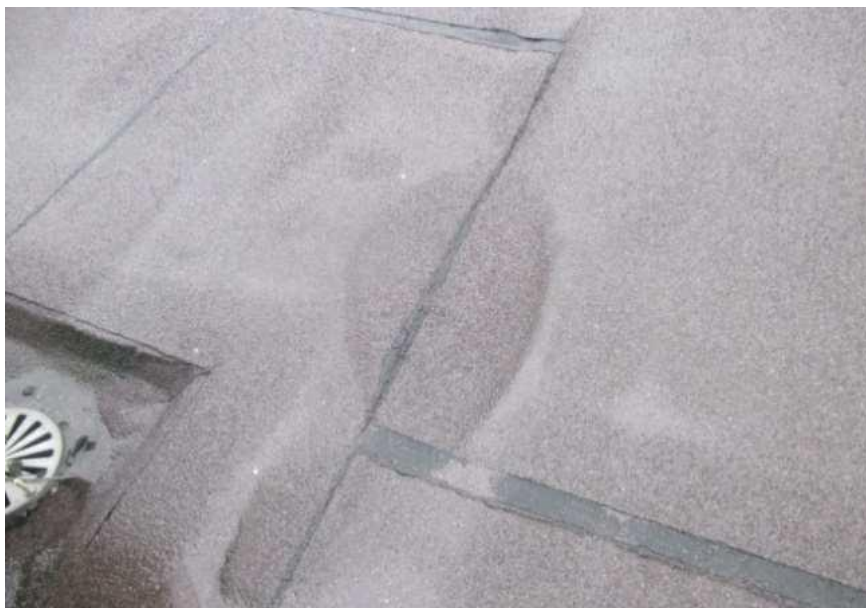
At HLC there is clear evidence of the failure of the roof covering along a number of seams. Substantial areas of the covering have also begun to fail due to UV light induced breakdown of the bitumen based coverings. There is evidence that water (from rain and snow etc.) is finding its way through the flat roof covering. The problem has been compounded by the theft of lead flashings which has allowed further water ingress. It is highly likely that there is rotting of the roof deck and possibly the timber supports. The extent of any such decay cannot be determined however without substantial unpicking of the structure. Without renewal of the roof structure there will be a structural failure of the existing roof at some future date.

Flat Roof Seams Showing Water Penetration

All show signs of advanced failure and will require replacement in the short to medium term if continued use of the building is planned.

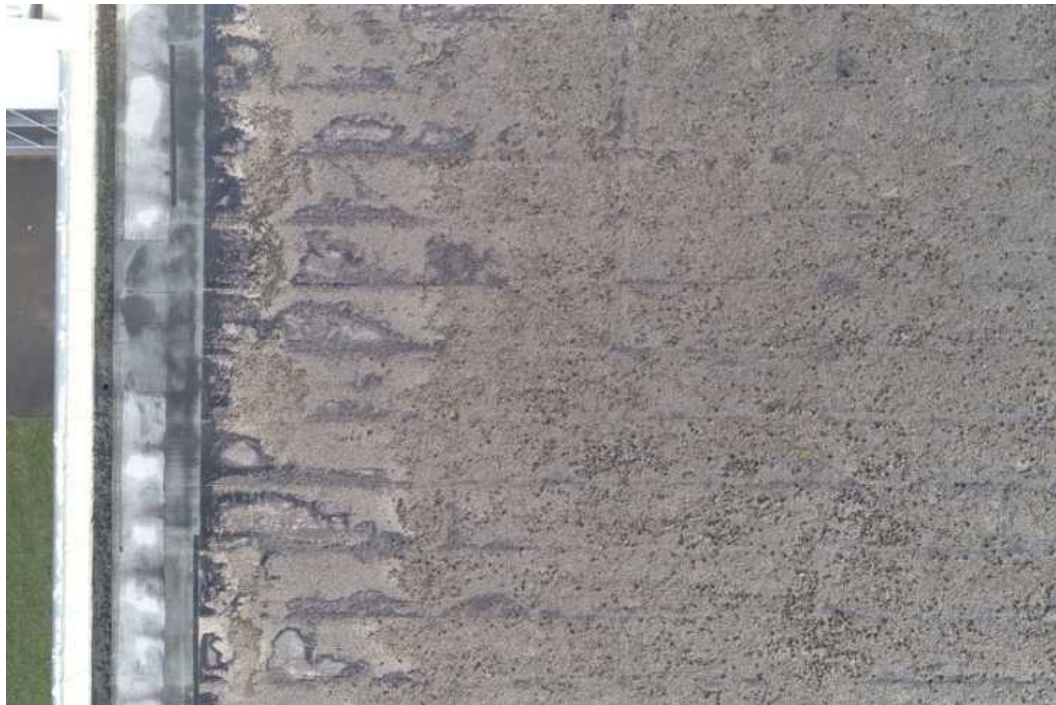
Breakdown of Bitumen Covering

“The roof to the swimming pool is life expired and requires wholesale replacement”.

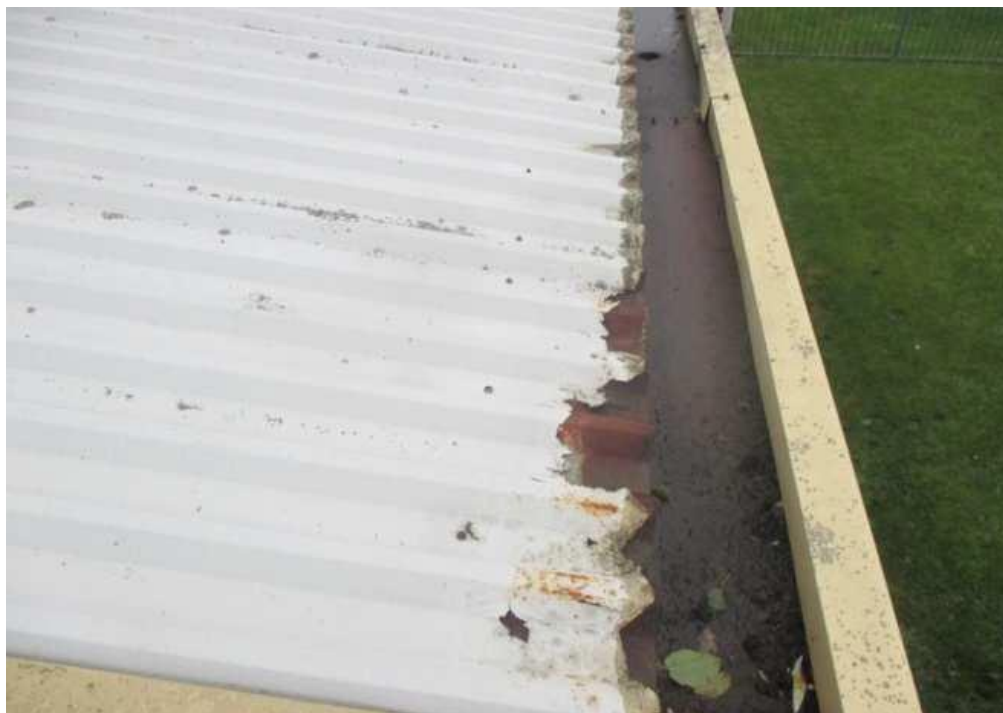
At HLC evidence of advanced corrosion of the edges of cladding panels can be observed. This gives rise to concern that fixing points may also be corroded and that panels could become detached in severe weather. This could only be disproved by a destructive survey involving the removal of areas of covering.

“the profiled metal roof covering to the sports hall, gym and dryside changing area is in poor condition. The roof sheets date from original construction in 1987 and are over 34 years old. The lap and gutter edges are suffering from cut edge corrosion. The corrosion is progressive and can be problematic if it extends to the fixing bolts for the roof sheets, which is likely to happen in the medium term without treatment”.

Corroded Edges to Cladding

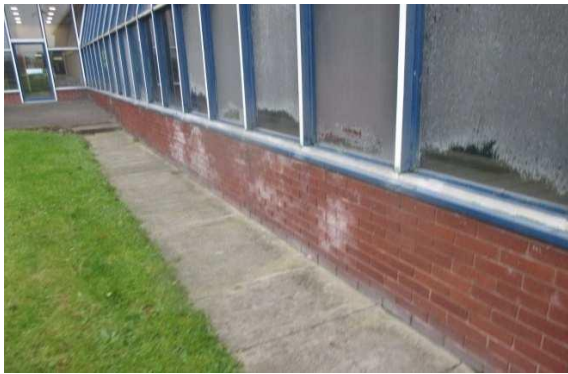
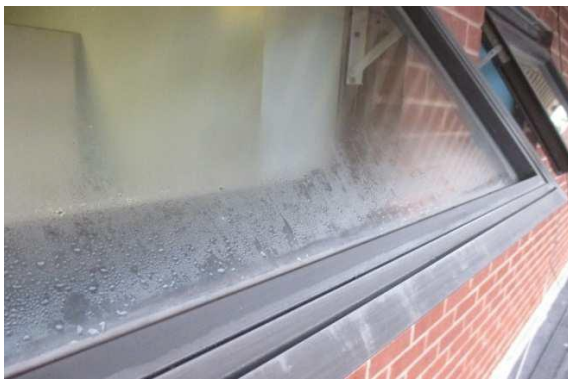
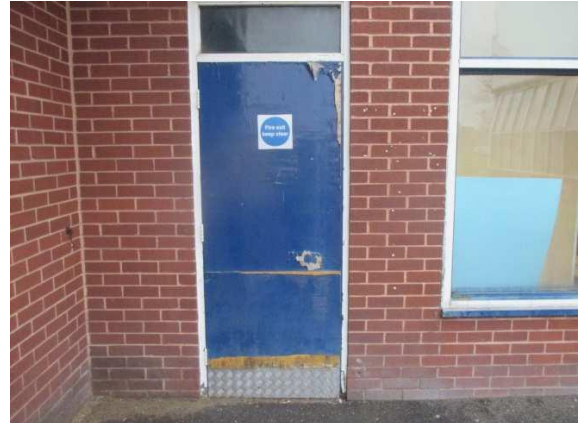
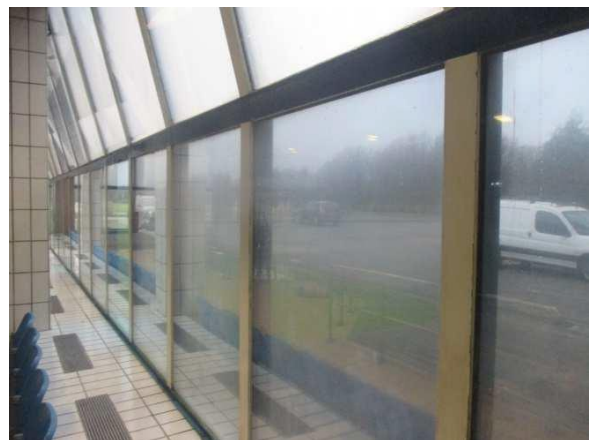
The most significant areas of building envelope failure are associated with the curtain walling. Almost all sections of curtain walling are exhibiting peeling of the protective coatings applied to the metal framework, whilst the seals on most glazing panels have also failed. The seals serve to keep an airtight gap between the two panes of glass in a double-glazed unit and to retain the glass unit in its surrounding frame. Seal failure is unsightly (the glass

Pictures above show failed window seals allowing misting of panels and poor condition of timber doors

“ The glazed curtain walling to the rear and left elevations of the indoor swimming pool and front elevation plant room is in poor condition. The pre-finished powder coating has been overpainted with a non-compatible decorative finish which has failed and is peeling. The double-glazed units have comprehensively failed with condensation built up between the panes. Moss growth is also evident to the seals of windows. The curtain walling is beyond economical repair and requires wholesale replacement.”

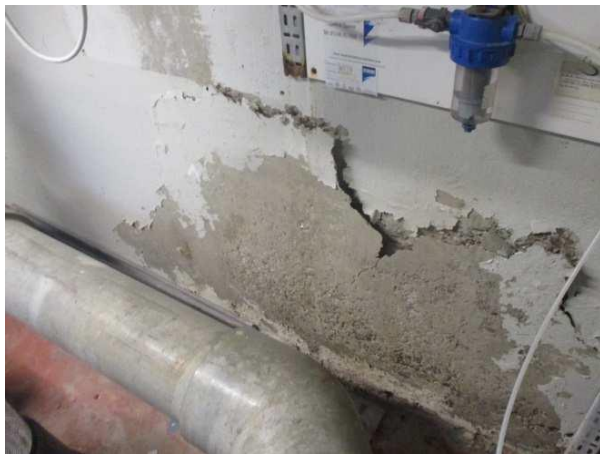
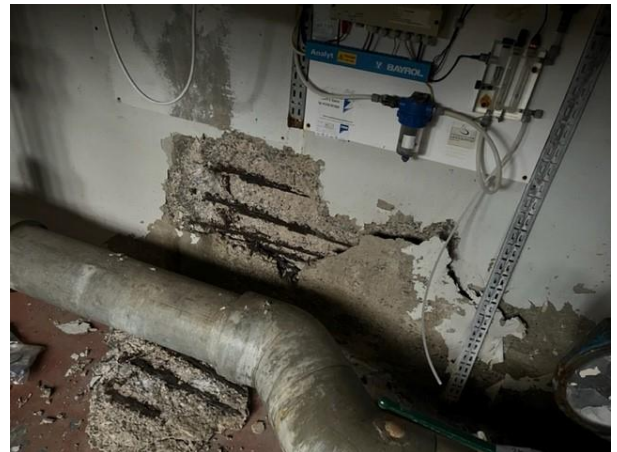
Left December 2021. Right August 2022

“the concrete structure to the swimming pool is cracked and spalled in several areas most likely due to the high levels of humidity and chemical use”.

“large parts of the concrete basin itself have detached and are moving away from the main structure suggesting that the reinforcement steel is corroded and expanding”

The above picture shows the Swimming Pool basin in the Plant Room. CBRE had concerns regarding the structural integrity of this area.

“Given the extent of deterioration seen, we recommend that a package of concrete testing is undertaken to determine the condition of the concrete itself and embedded steelwork. The test results should be reviewed by a structural engineer and a package of remedial works undertaken prior to any proposed re- use being considered”.

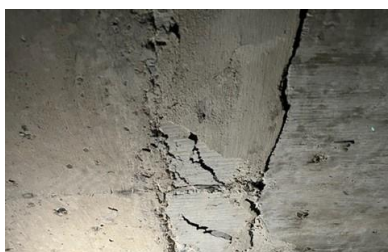
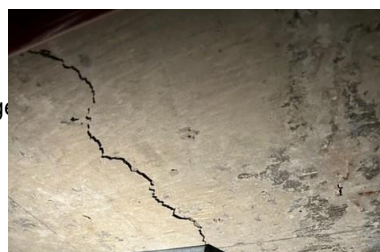
Structural Cracking To Pool Basin

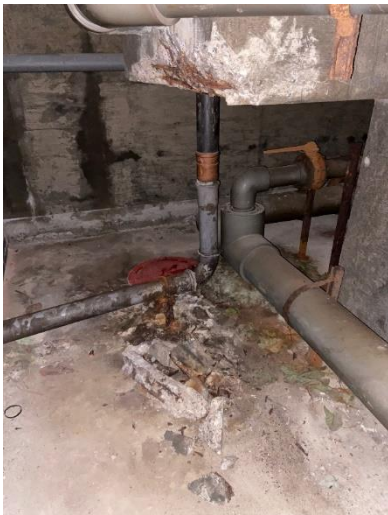
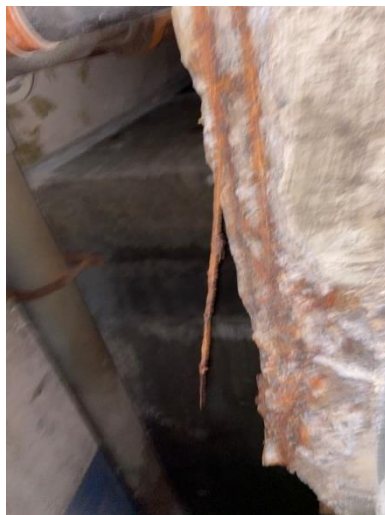
Corrosion of Reinforcement Within Structural Concrete

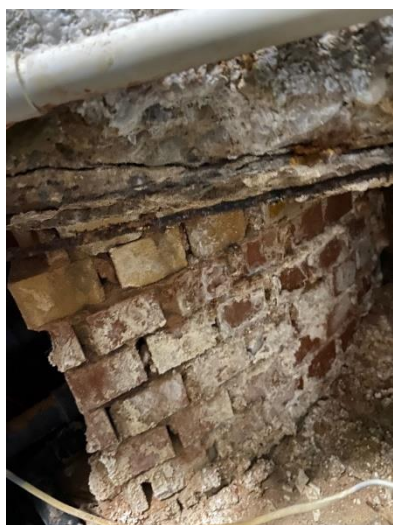
Deterioration Of Supports to Health Suite

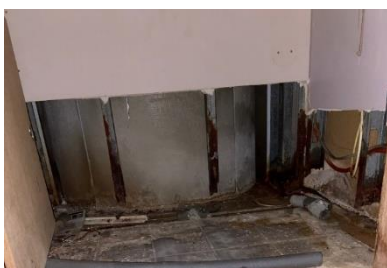
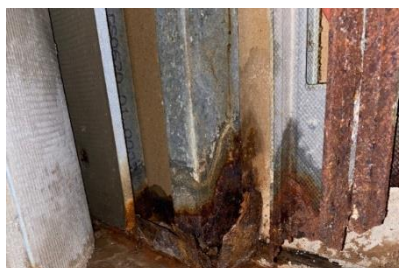
Corrosion Of Steel Supports
