KAP/J/10203A

STRUCTURAL INSPECTION

REAR OF 49 MARKET STREET

ASHBY DE LA ZOUCH

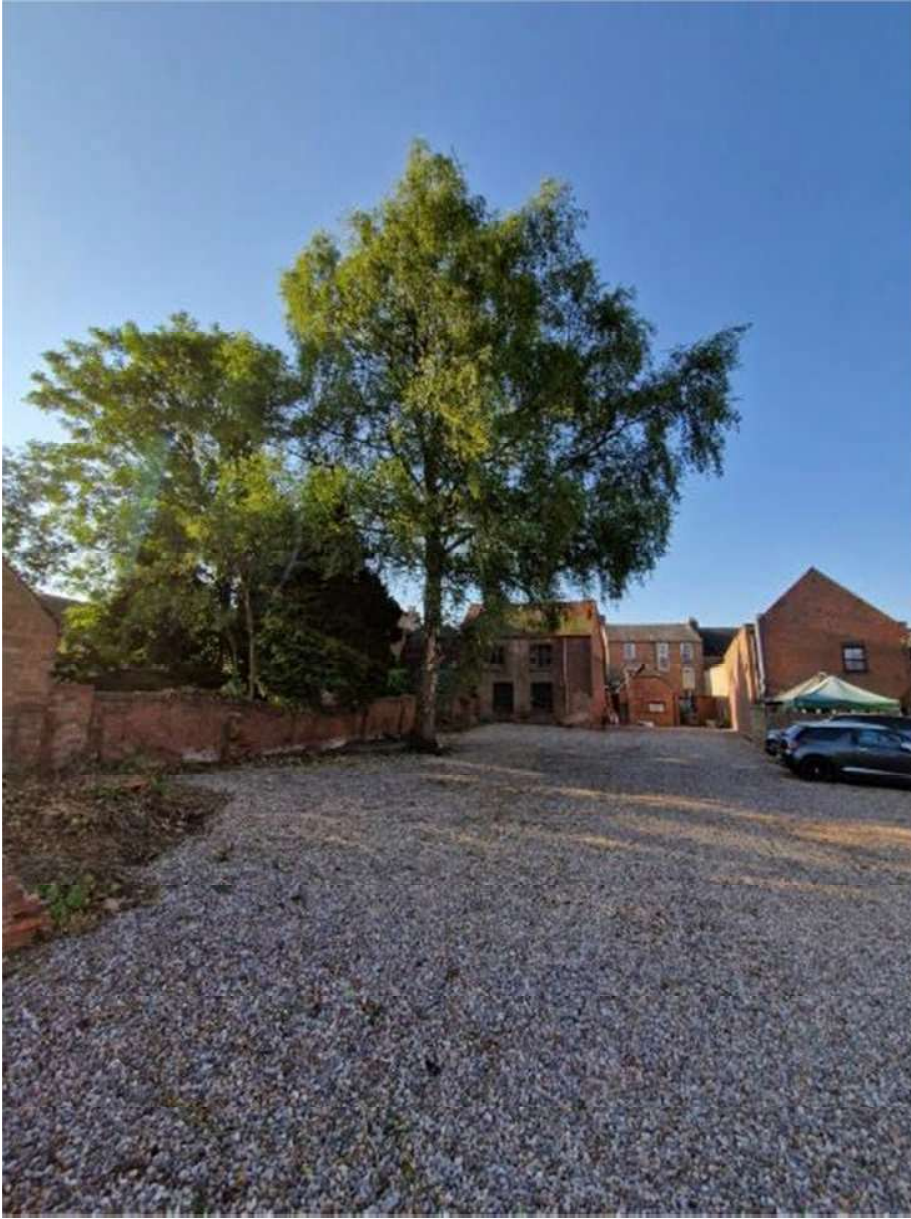
Wall looking to the front.

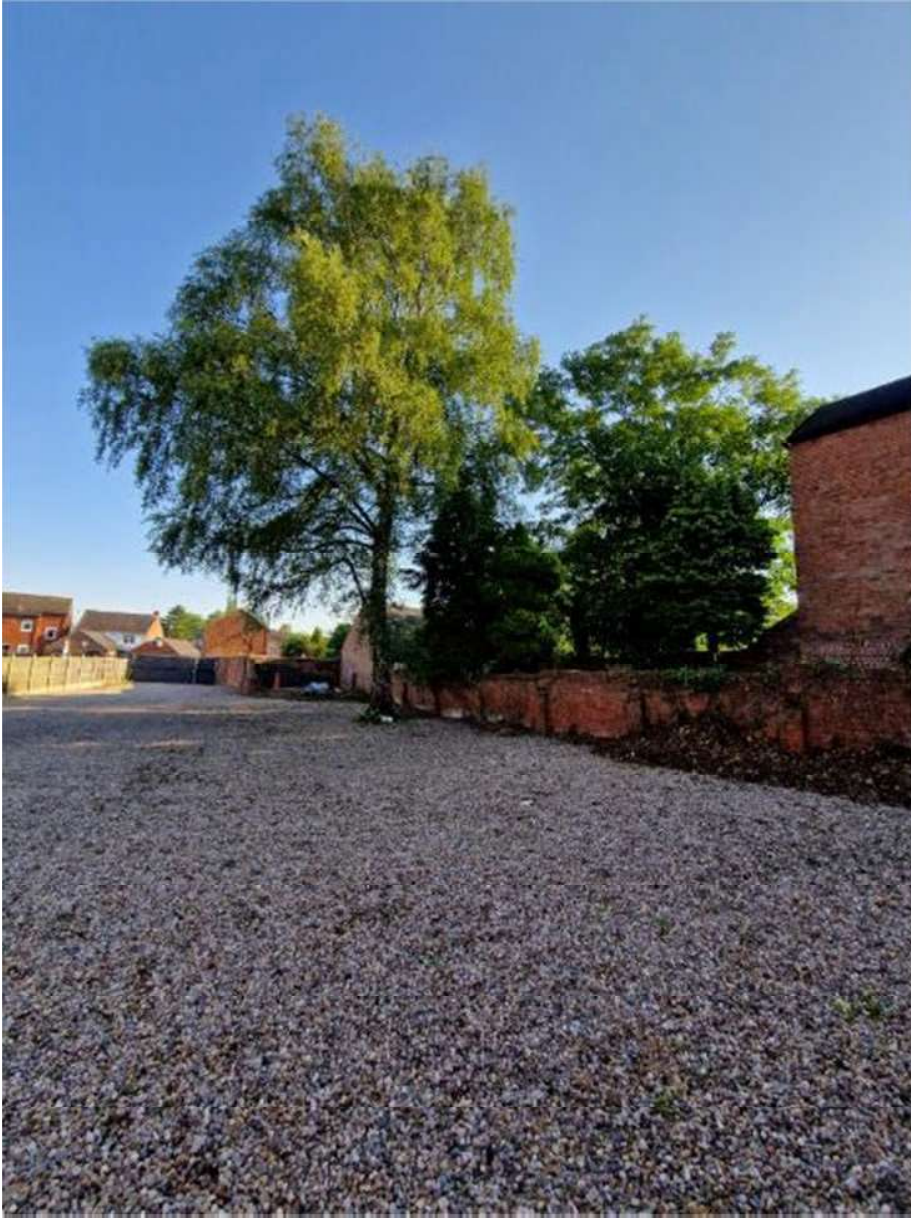
Wall looking to the rear.

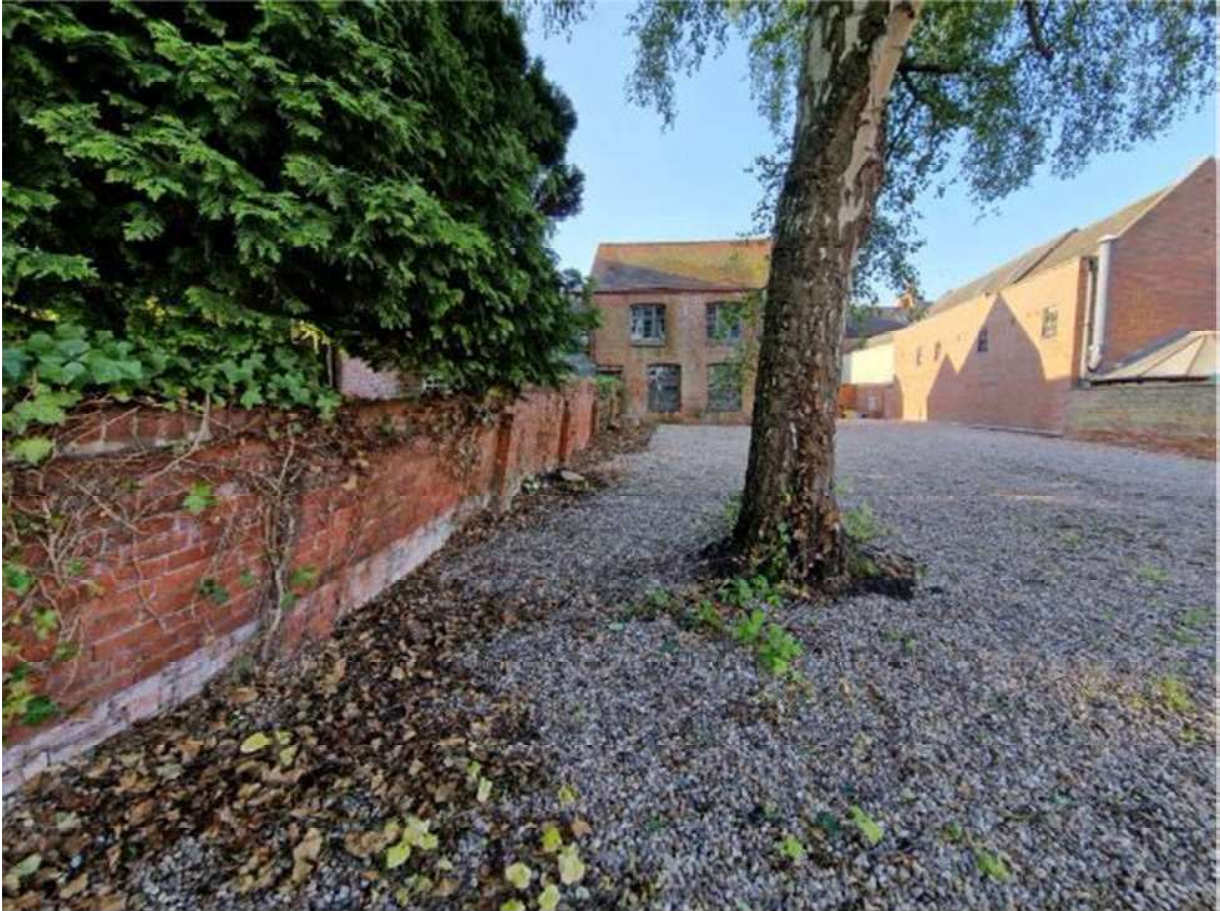
Tree is very close to the wall causing it to become unstable.

1. The trees adjacent to the rear boundary wall are having an adverse effect on the stability of the wall.
2. It is recommended that the trees are removed as soon as possible. The removal of the trees should include the root system. Where this creates a void adjacent to the foundations of the wall this void should be filled using concrete.
3. The wall is at such an angle that it is no longer considered to be stable. It is recommended that the deformed sections of the wall are taken down and rebuilt. It will be possible to do this by re-using the existing bricks, however, it is inevitable that some bricks will become damaged by the demolition of the wall and the cleaning of the bricks that other bricks will need to be sourced to replace them.

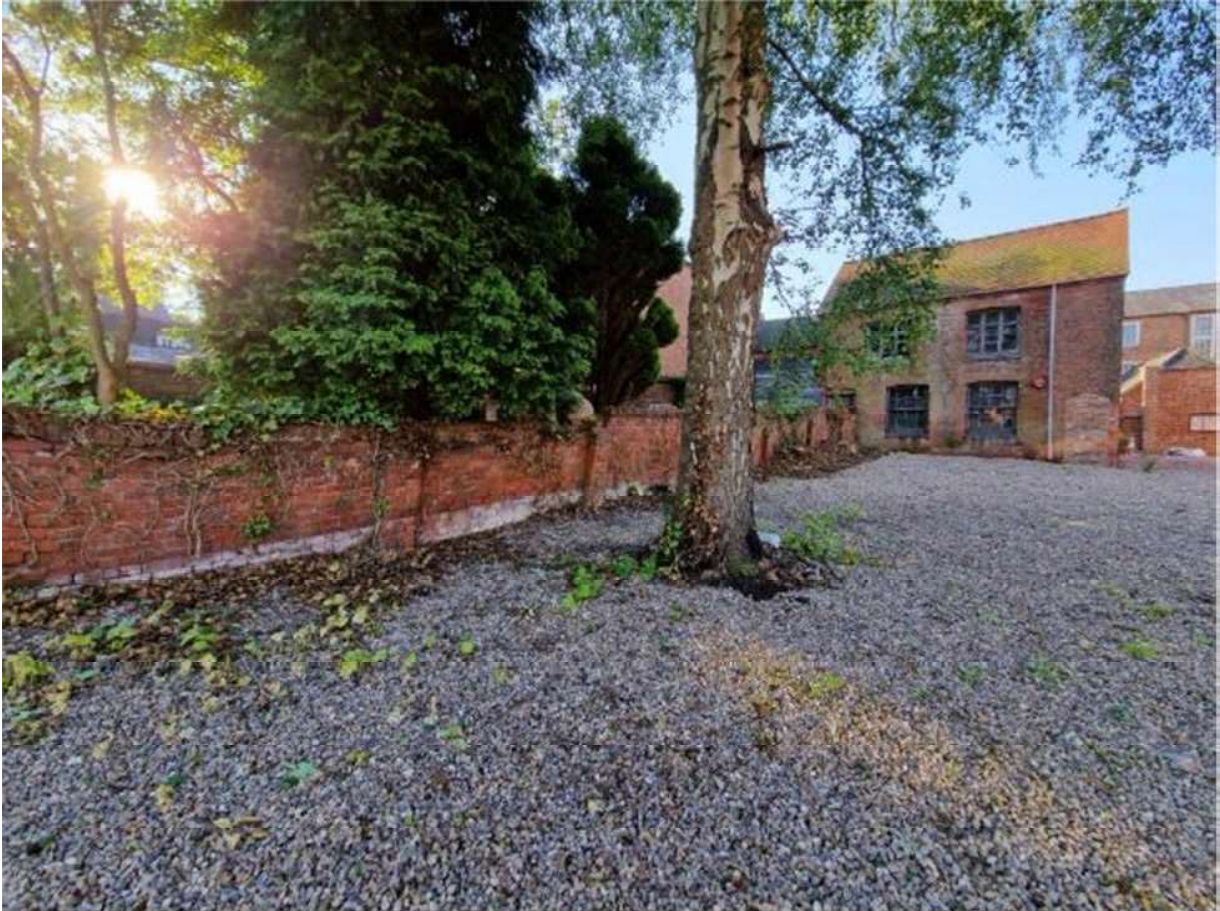
Tree outside the wall line are also influencing the wall stability.

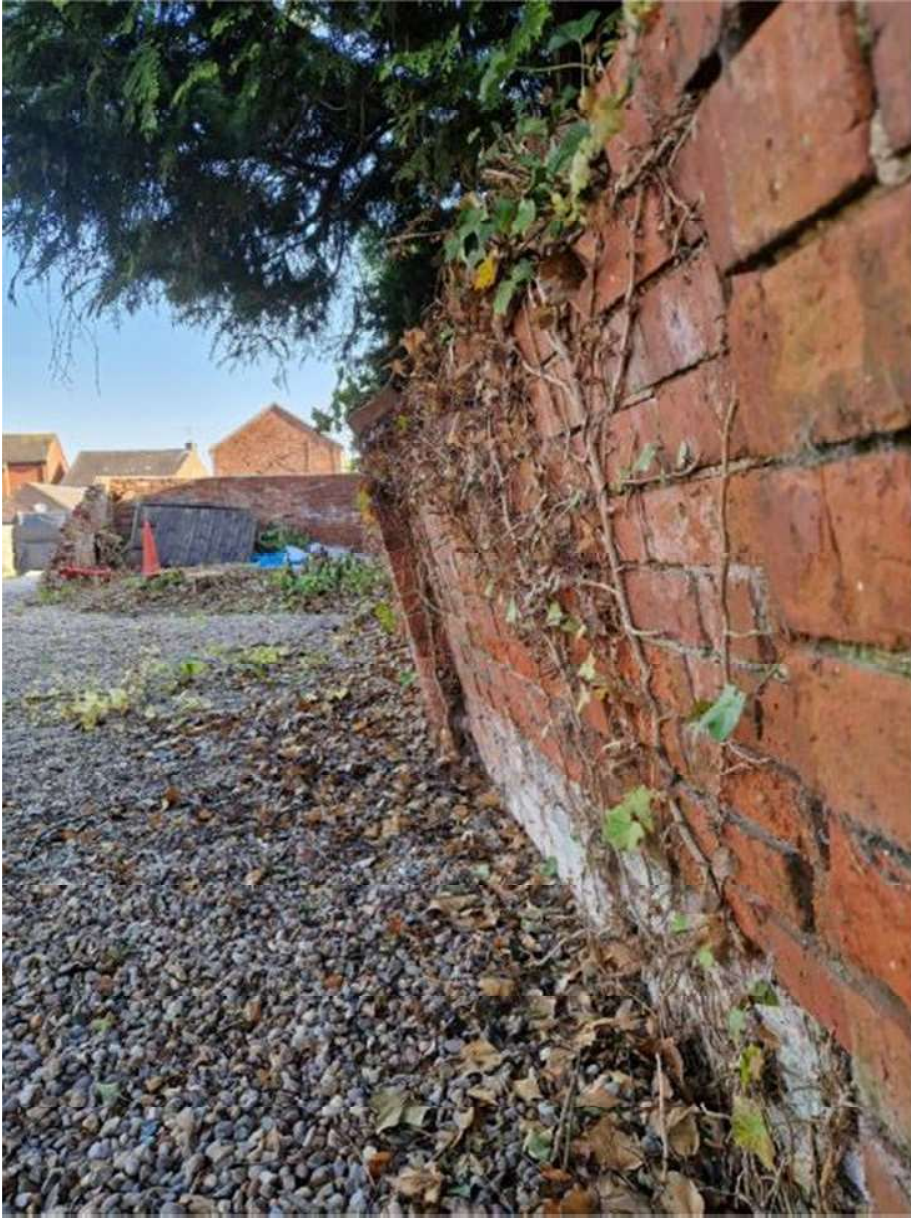
The wall is leaning at such an angle that it is unstable.

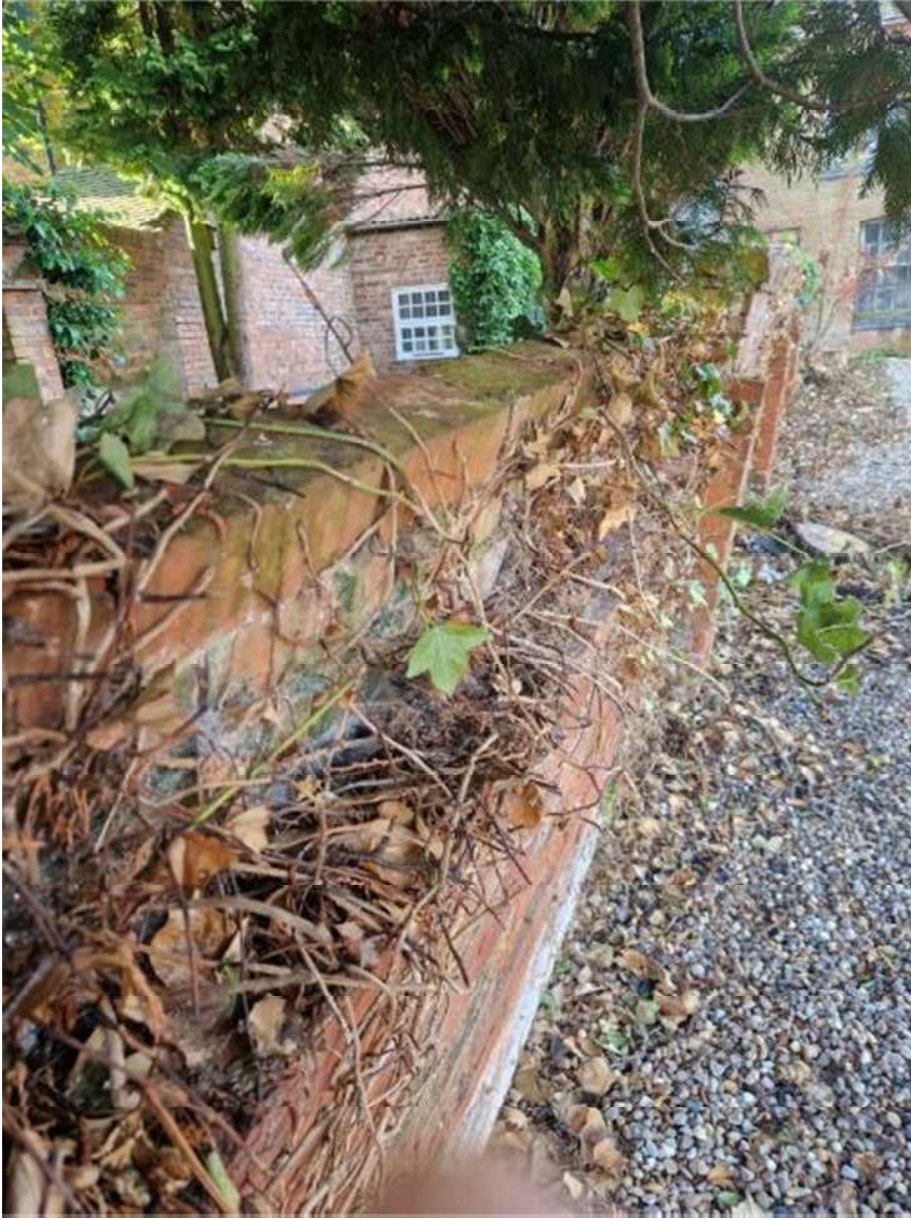
Trees are having a severe impact on the wall.

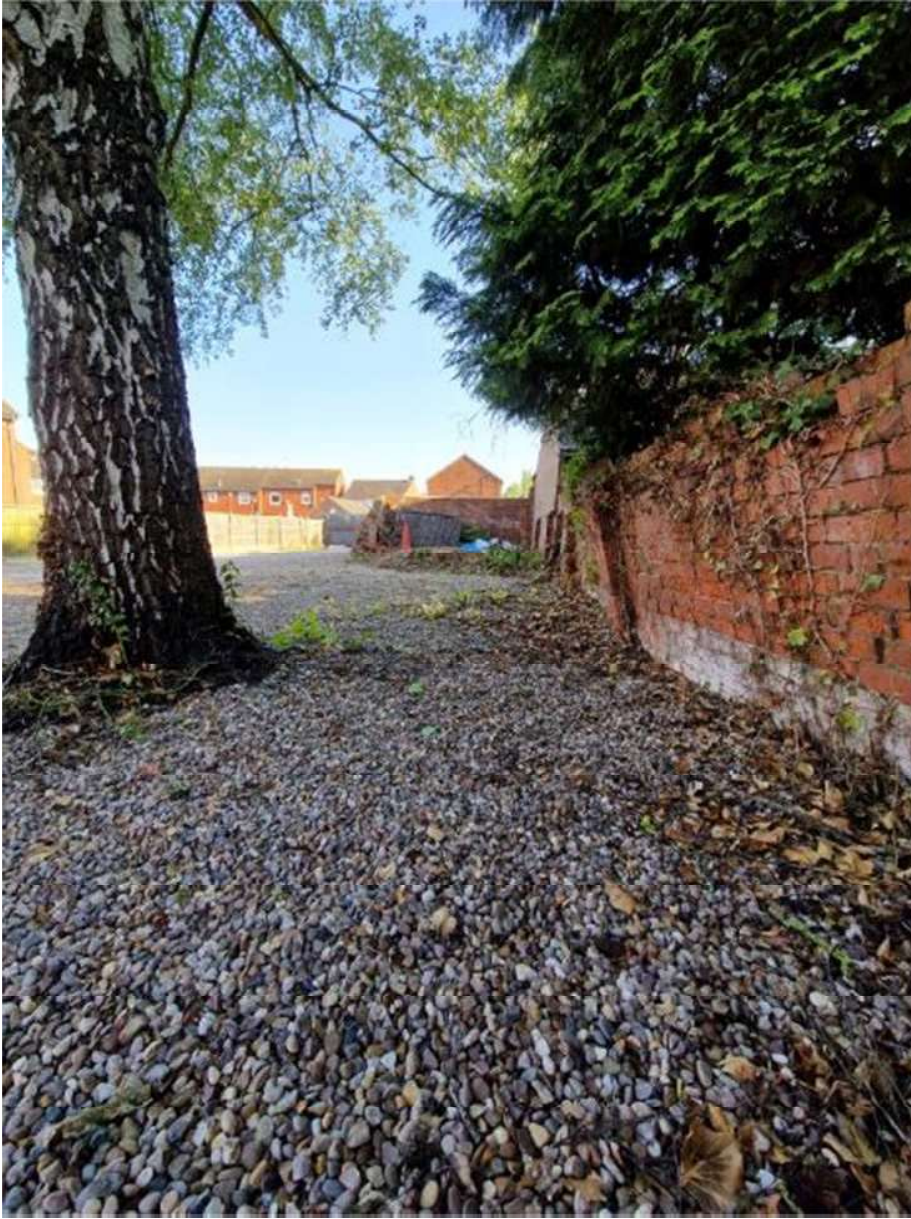
The wall is in a distressed state.
