**IBSTOCK CONSERVATION AREA
CHARACTER APPRAISAL**

**REVISED
OCTOBER 2017**

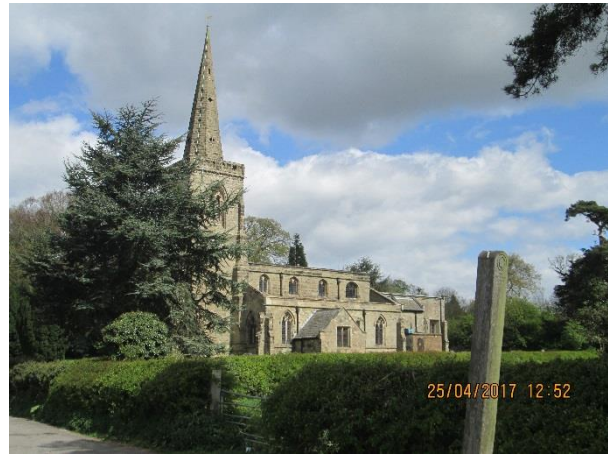
3.7. Ibstock appears in the Domesday Book of 1086 as *lbestoche*. While the Church of St Denys (pictured) is “almost entirely of the early fourteenth century”, it is considered “probable that a Norman church stood on the present site” (Pevsner, 1984; Armson, 1938).

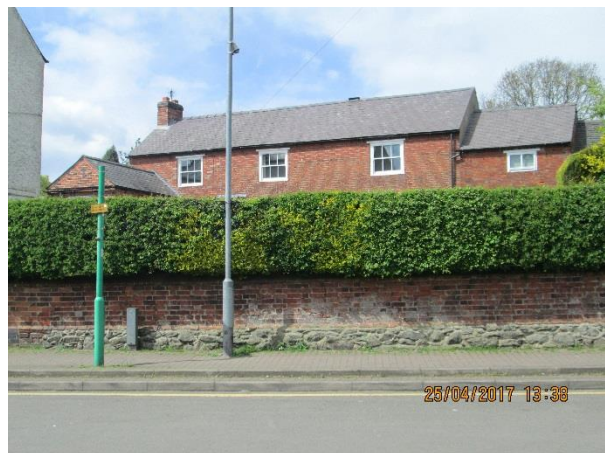
- 3.15. Fourthorn Farm (pictured) dates to the early eighteenth century. Cawte (2000) says that “the earliest known deeds are 1735”. The Manor House was altered substantially in the mid eighteenth century; Cawte (2000) identifies a Georgian wing, “probably built by Joseph Paget, who bought the property in 1748”. The house was known as Ibstock House until c.1901-03.

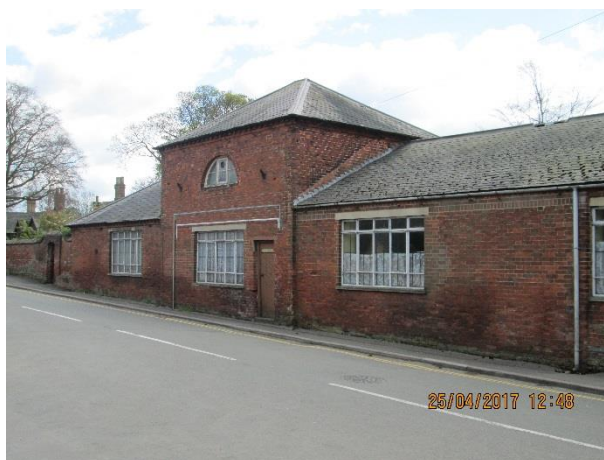
4.3. In 1954 permission was granted for the subdivision of the rectory into two dwellings (our reference IB54/4198). A coach house was altered to form a church hall³. The church hall (pictured) opened in October 1958.

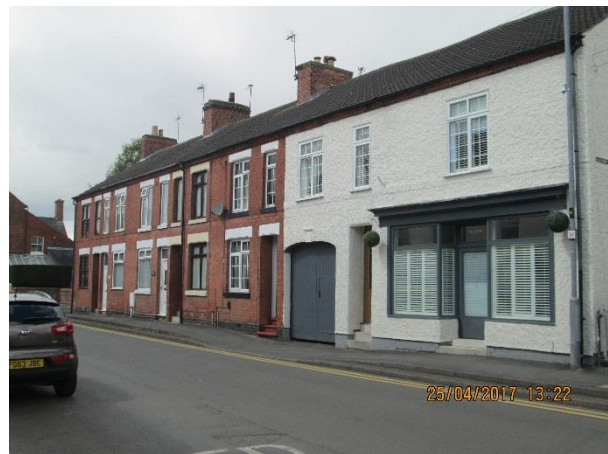
- 5.5. Render may appear more jarring when applied to part of a uniform red brick terrace. Examples include 1 to 5 Hinckley Road and 136 to 148 High Street.

8.6. Red brick is the characteristic facing material locally. The majority of buildings are faced in red brick, with a substantial minority faced in render. Render may appear more jarring when applied to part of a uniform red brick terrace. In such cases, the opportunity to remove render should be investigated.

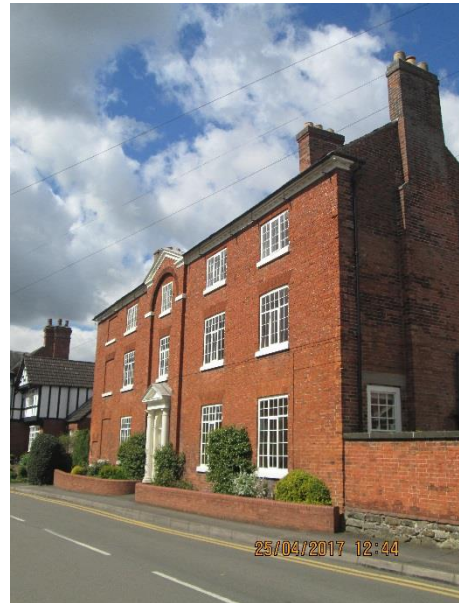
- 5.20. Properties in this character zone are generally two storeys in height. Taller buildings have landmark value; they include Holmsdale Manor (pictured), 111 High Street and 121 High Street. The majority of properties are faced in red brick but a substantial minority are rendered. The majority of properties have slate roofs; non-traditional roof coverings intrude to a lesser extent.

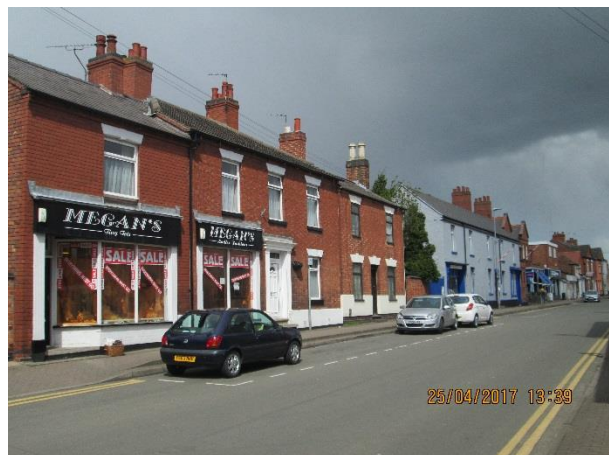
- 5.24. Generally traditional shop fronts survive; for example note the shop fronts at 52 High Street and 78 & 80 High Street (pictured). Some retail properties have been converted for use as dwellings, but retaining traditional shop front features. These properties are indicated on map 6 with a thick black line.

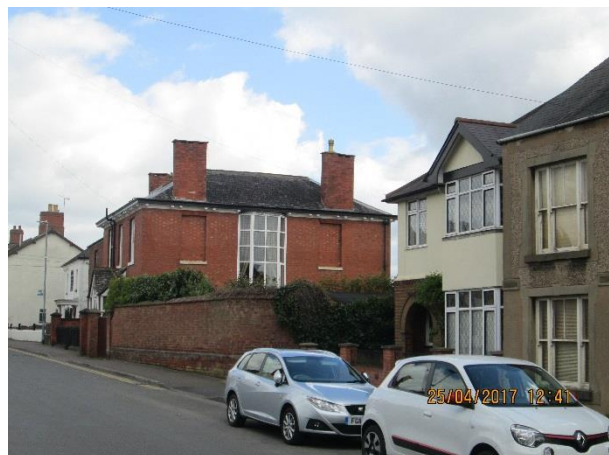
- 7.3. The side elevation of 111 High Street closes the long view along the High Street looking NE. The elevation (pictured) features a distinctive full-height bay window.

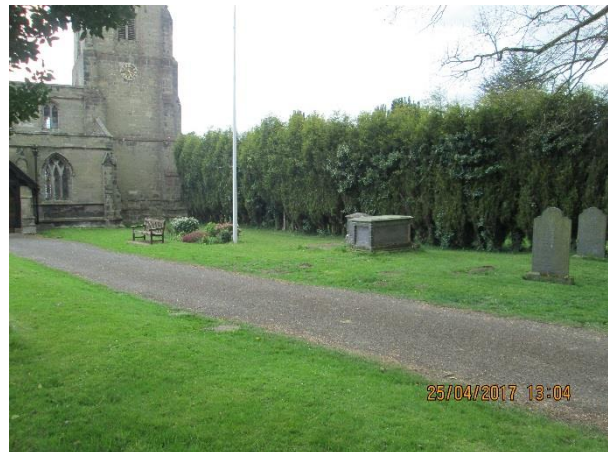
- 8.11. The churchyard is bisected by a coniferous hedge (pictured); visually it does not contribute positively to the conservation area. There is an opportunity to enhance the significance of the conservation area by replacing this hedge with (e.g.) a broad leaved evergreen hedge.

- 6.4. The churchyard is bisected by a coniferous hedge. It may alleviate noise from Hinckley Road but visually it does not contribute positively to the conservation area.
