**SHOP FRONTS AND ADVERTISEMENTS
SUPPLEMENTARY PLANNING DOCUMENT**

ANNEX: TRADITIONAL SHOP FRONT DETAILS

MAY 2019

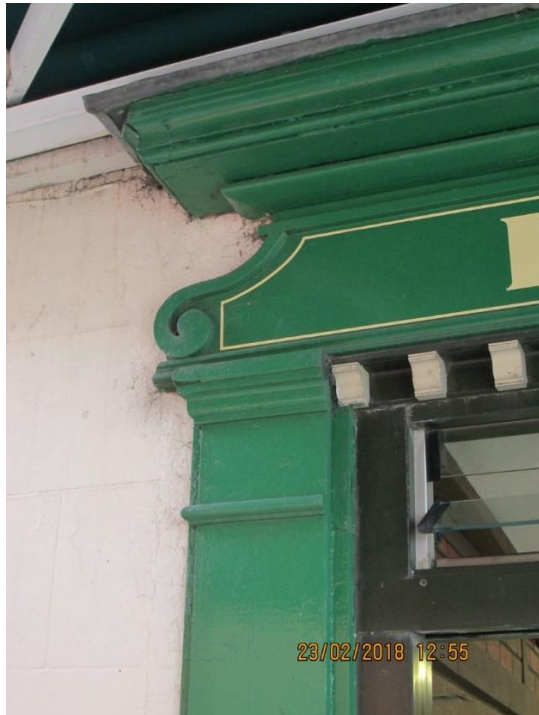
34 Market Street, Ashby. A plain pilaster with a Roman Doric capital carries a frieze with an unusual scrolled edge. The shop display window has been replaced.

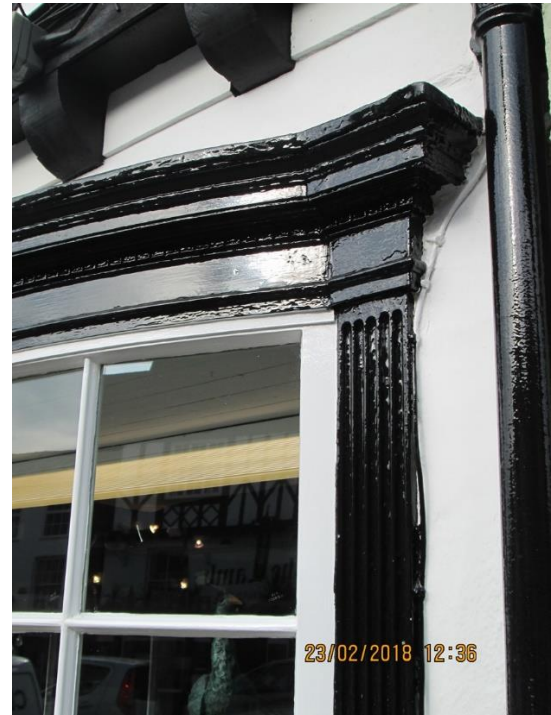
51 Market Street, Ashby. A fluted pilaster with a simple capital supported a shallow frieze and cornice. The shop window is bowed and divided into small panes.

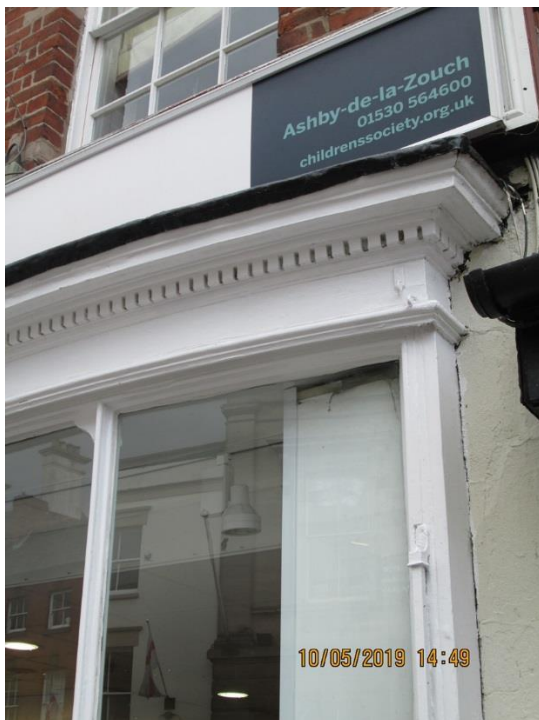
65 Market Street, Ashby. A slim fluted pilaster with no capital carries a frieze and a dentil cornice. The shop window is bowed and contains vertical glazing bars.

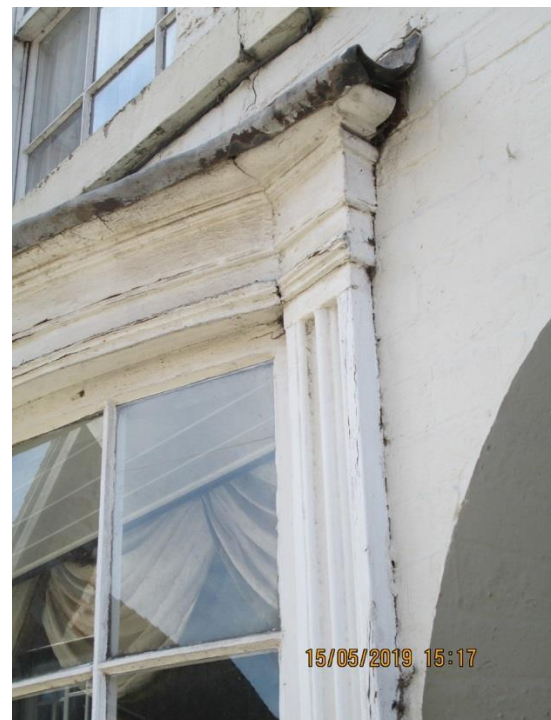
24 Clapgun Street, Castle Donington. A fluted pilaster with a simple capital carries a shallow frieze and cornice. The shop window is bowed and divided into small panes. No longer a shop.

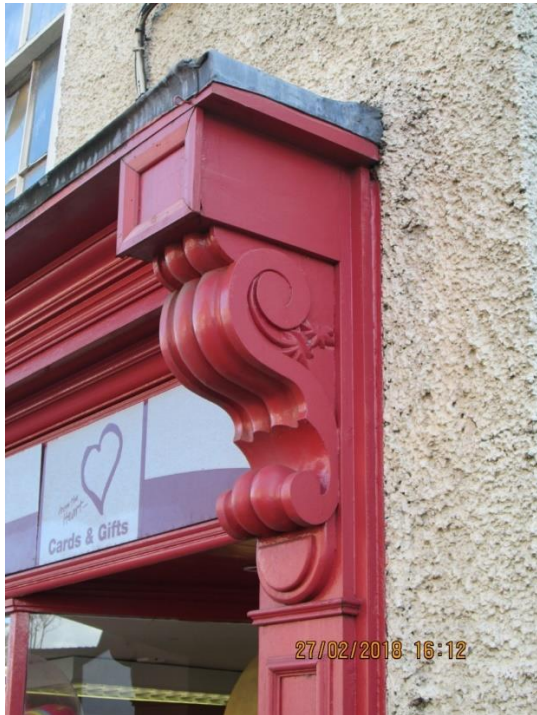
16 Market Street, Ashby. A pilaster with false panelling carries a scroll bracket with a square head. There is a flat fascia with cornice. This shop front has been altered.

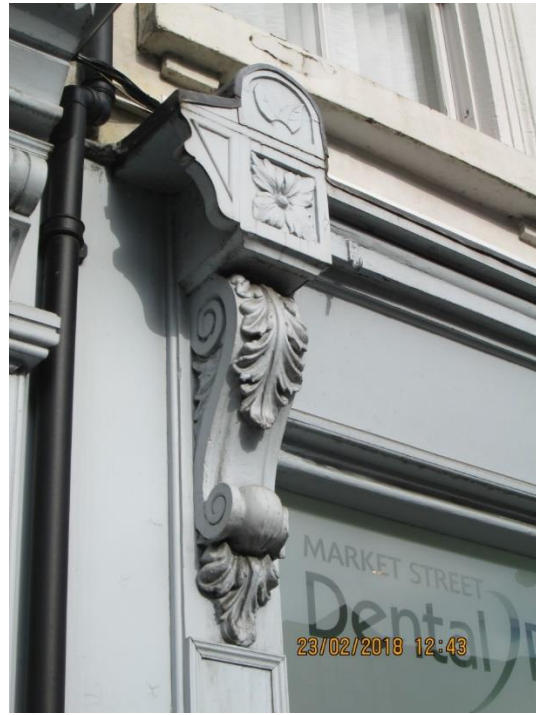
83 Market Street, Ashby. A pilaster with false panelling carries a scroll bracket with a round head. There is a canted fascia. The shop display window has been replaced.

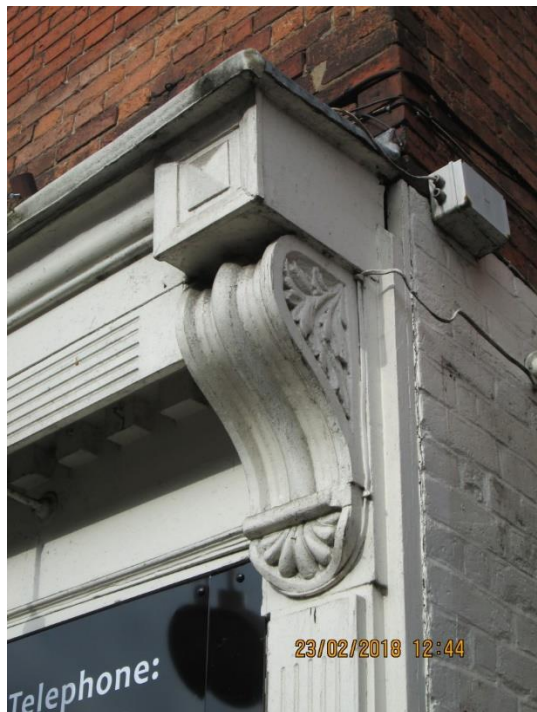
85 Market Street, Ashby. A fluted pilaster carries a scroll bracket with a square head. There is a flat fascia with dentil cornice. The shop display window has been replaced.

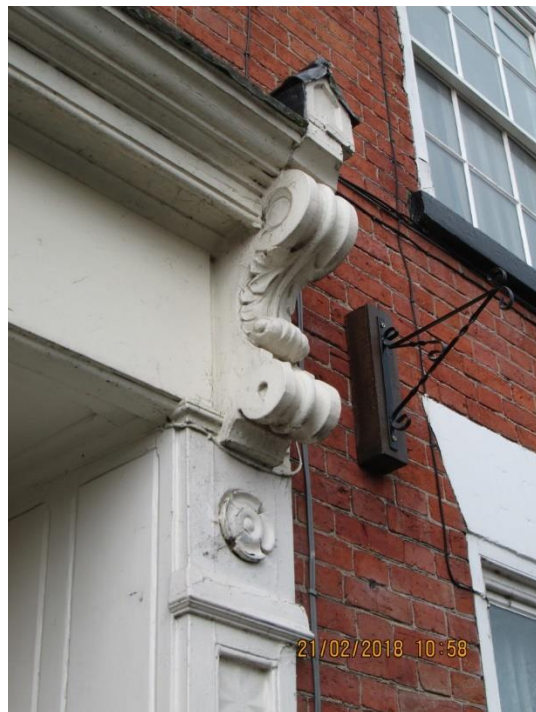
3 High Street, Kegworth. A panellled pilaster with a capital carries a scroll bracket with a gabled head. There is a flat fascia with cornice. Note the panelling in the door recess.

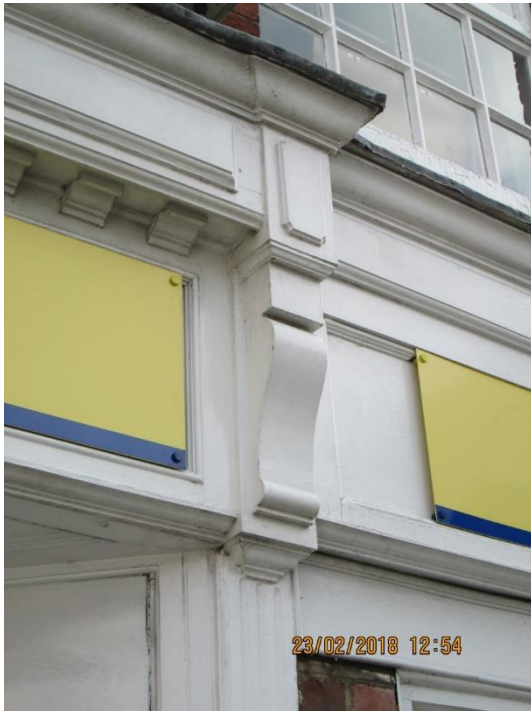
34A Market Street, Ashby. c.1930. A fluted pilaster carries a simple scroll bracket. The cornice is advanced over the head of the bracket. There is a flat fascia.

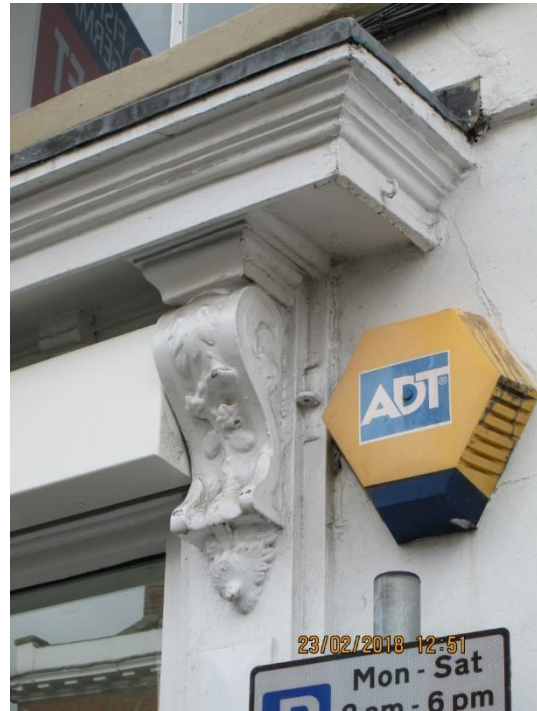
70 Market Street, Ashby. A pilaster with a raised panel carries a scroll bracket; it does not break through the cornice. This shop front has been altered; the fascia is obscured.

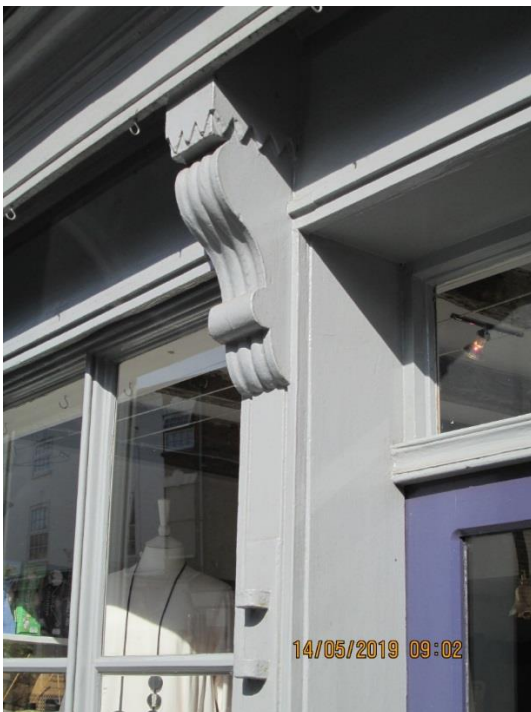
33 Borough Street, Castle Donington. An incised pilaster carries a scroll bracket; it does not break through the cornice. There is a flat fascia. Note the vertical glazing bar.

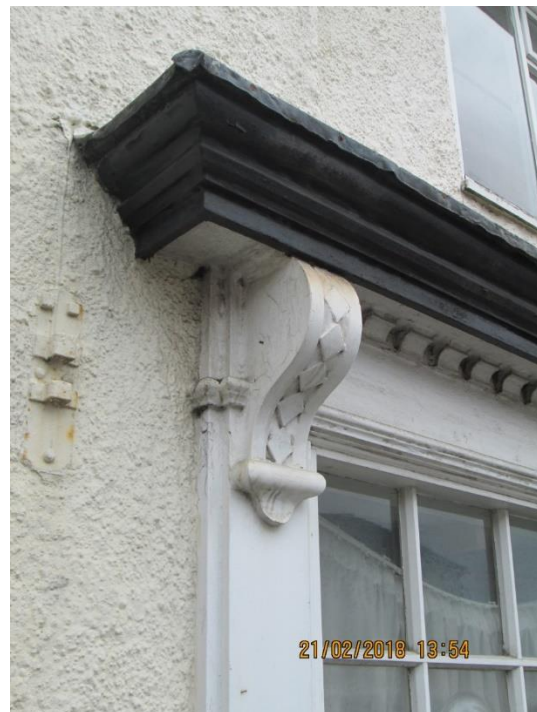
43 High Street, Measham. A plain pilaster carries a scroll bracket; it does not break through the cornice. The shop display window has been replaced. No longer a shop.

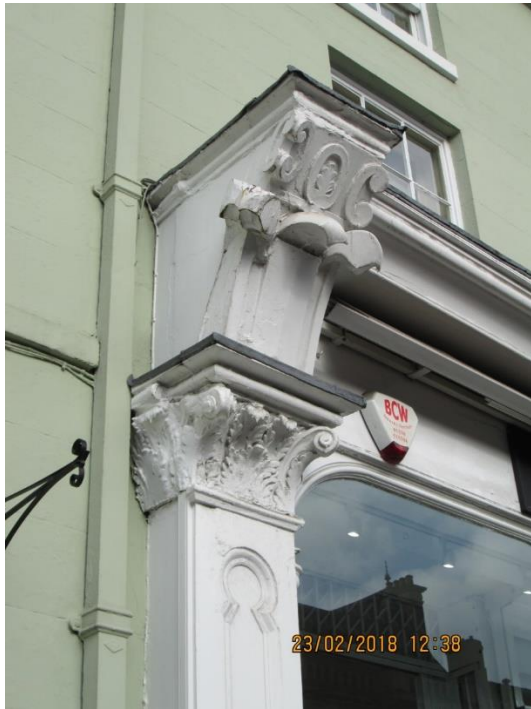
53 Market Street, Ashby. A panelled pilaster with a corinthian capital carries an unusual bracket with a flat head. There is a flat fascia with a box cornice. An ornate shop front.

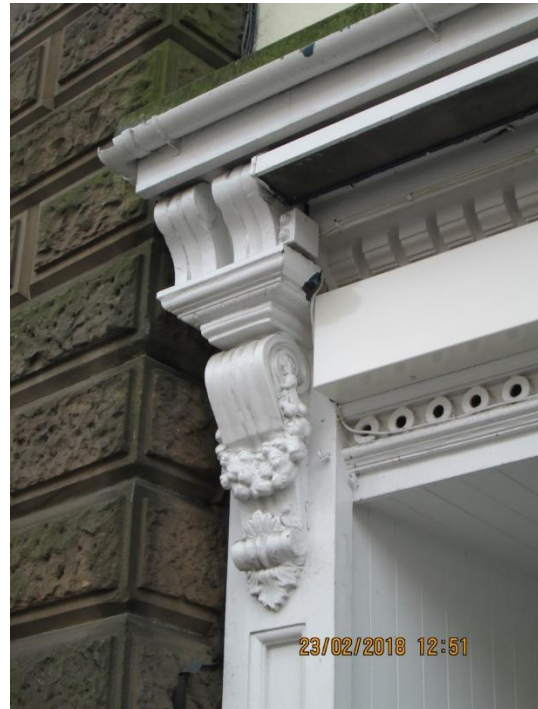
72 Market Street, Ashby. A panelled pilaster carries an unusual bracket; it does not break through the cornice. Altered; the fascia is obscured and the cornice is modern.

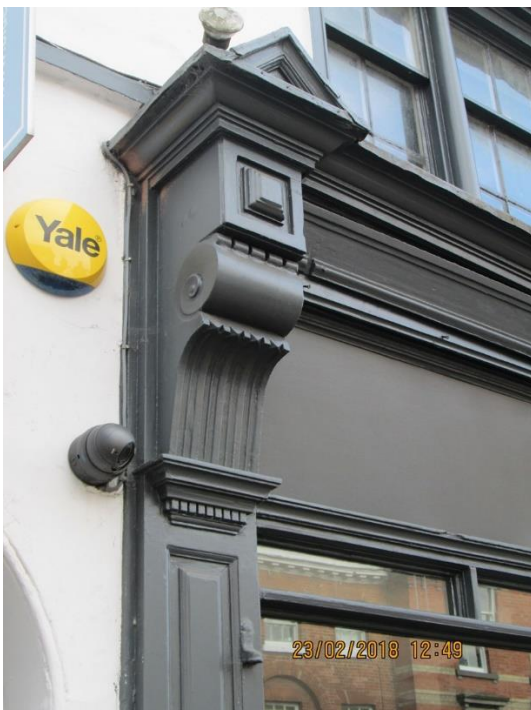
76 Market Street, Ashby. A panelled pilaster carries an unusual bracket with a gabled head. There is a canted fascia. The cornice contains a roller blind.

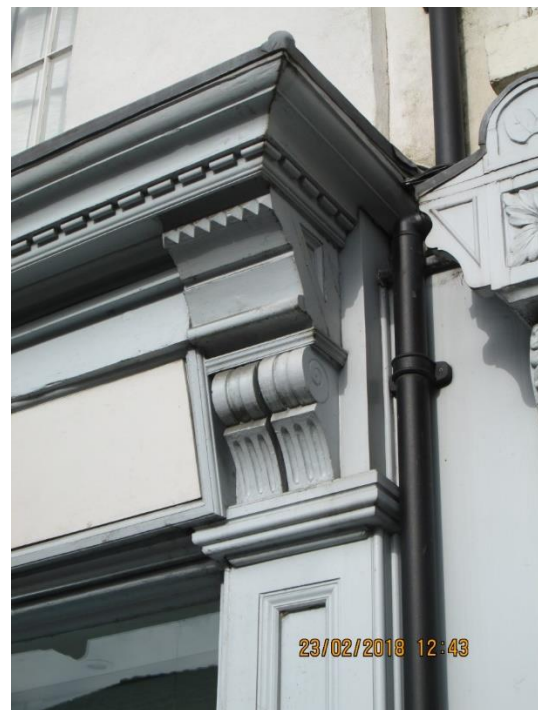
81 Market Street, Ashby. A panelled pilaster carries an unusual bracket; it does not break through the cornice. There is a canted fascia. This shop front has been altered.
