ASHBY 'TOWN' CONSERVATION AREA CHARACTER APPRAISAL

Appendix 2A

**REVISED
JULY 2024**

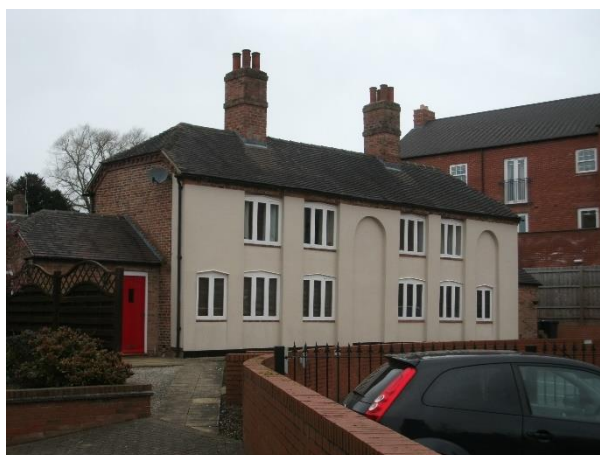
- 32 ‘retirement apartments’ on Kilwardby Street (‘Bainbridge Court’) erected c.2014.
- 1.4. Alpha Cottages¹ (pictured) and the former Hare & Hounds PH were described as long term vacant buildings in April 2001. The properties were brought back into use c.2001 and c.2002 respectively (our references 01/01342/FUL and 02/00042/FUL).

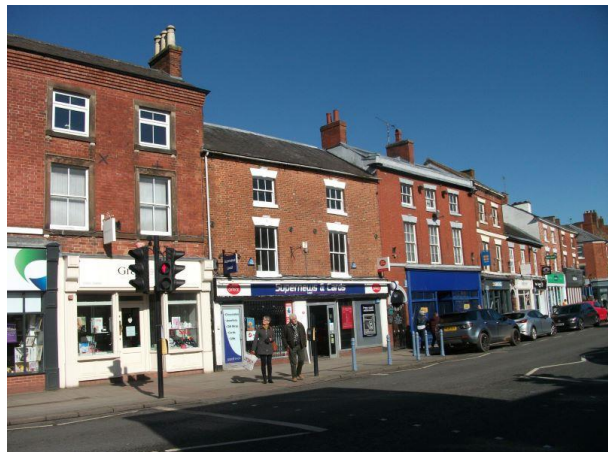
Market Street west

- 2.8.1. Generally buildings are arranged in terraced groups around a linear open space; some courtyard development survives. Generally buildings are three storeys tall. Most buildings are faced in red brick but a substantial minority are faced in render. The character zone contains 29 listed buildings.

- 2.8.2. Four buildings on the south side of Market Street do not contribute positively to character. In the long term there are opportunities to enhance character through the replacement of these buildings:
- **12 and 14 Market Street:** The building does not reflect the massing and materials of the character zone.
 - **42 to 48 Market Street:** This large building does not reflect the scale of the character zone; it contributes negatively to views of the church tower from the west. 42 Market Street has an untreated aluminium shop front.

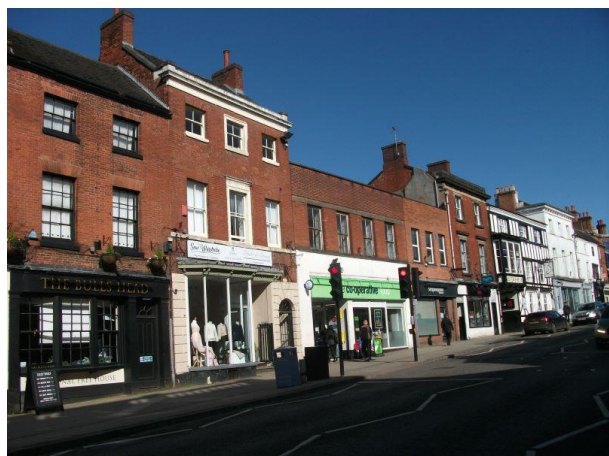
Market Street east

- 2.8.4. Generally buildings are arranged in terraced groups and laid out to the back of the pavement. Some courtyard development survives but much was demolished c.1948-71. Generally buildings are three storeys tall. Most buildings are faced in red brick but a substantial minority are faced in render. The character zone contains 22 listed buildings. The Bulls Head PH (67 Market Street) is a grade II* listed building.

- 2.8.5. Two buildings in the character zone do not contribute positively to character. In the long term there are opportunities to enhance character through the replacement of these buildings:
- **57 and 59 Market Street:** This large building does not reflect the scale of the character zone.
 - **73 and 75 Market Street:** The two-storey flat-roofed building does not reflect the scale and massing of the character zone.
- 2.8.6. To the west of the Market Hall, flat-roofed elements do not reflect the scale and massing of the character zone. Buildings to the south west of Bakery Court were demolished after 1971. The buildings were replaced by a surface car park that does not contribute positively to character. In the long term there is an opportunity to enhance character through the demolition of the flat-roofed elements and the redevelopment of the surface car park.

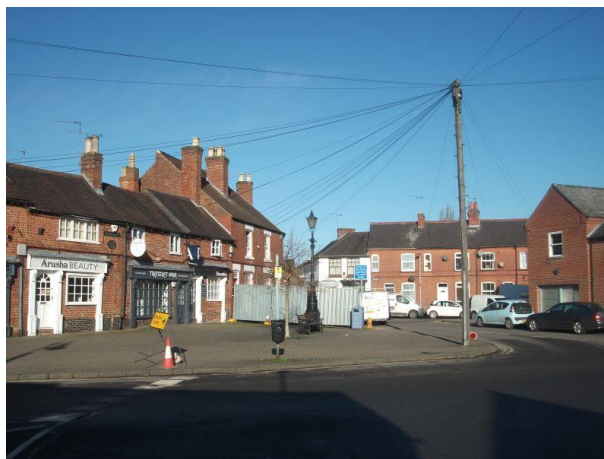
- 2.8.8. Generally buildings are arranged in terraced groups around an irregular open space (pictured right). Generally buildings are 1½ or 2 storeys tall. Generally buildings are faced in red brick. 8 to 12 The Green, 1 North Street and a former lamp standard are grade II listed buildings.

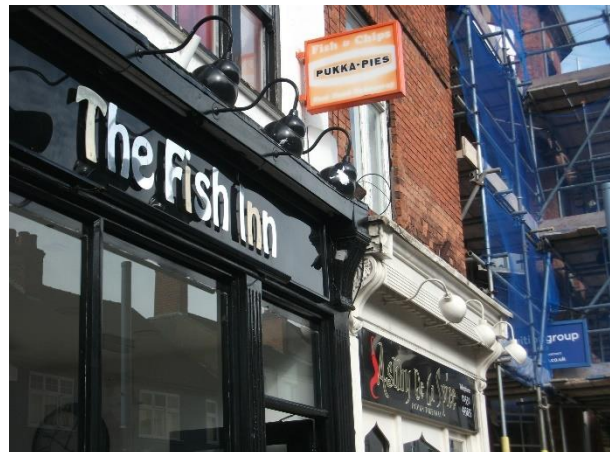
2.17. The SPD encourages trough lighting “set flush to the fascia” but advises that “swan neck lights are rarely acceptable in historic contexts”. Three listed buildings feature swan neck lights; all are hot food takeaways (77 Market Street; 85 & 85A Market Street; 88 Market Street). The SPD advises that a new shop front may accommodate lighting “within or under the cornice”; 25 Market Street is an example of good practice.

2.18. The SPD advises that signs “should be considered as an integral element in the design”. It advises that “where there is no fascia, consider applying lettering to the shop window or upper floors”. At 94 and 96 Market Street fascia signs have been installed in a manner that obscures the frieze and cornice. At 50 and 84 Market Street panel signs have been attached to buildings “where there is no fascia”⁶. The SPD advises that lettering should be “painted directly onto the shop front rather than on a board which is then stuck onto the shop front”; 72 Market Street is an example of bad practice.

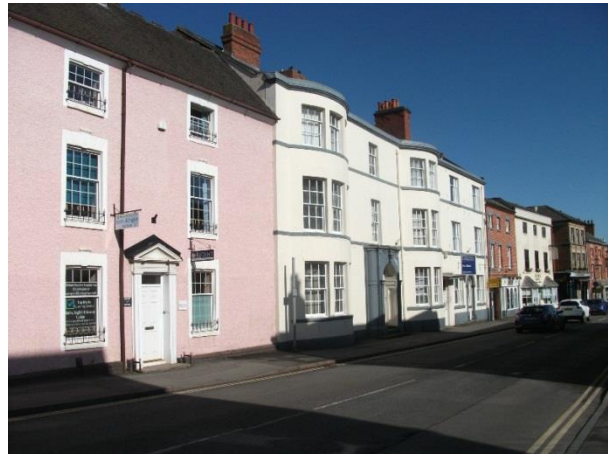
Kilwardby Street east

- 2.21.1. This character zone contains a diversity of uses. Generally buildings are arranged in terraced groups and laid out to the back of the pavement. Generally buildings are 3 storeys tall. Generally buildings are faced in render. The character zone contains 9 listed buildings.

- 2.21.2. A non-conformist chapel and school were demolished c.1985 and replaced by an access drive. In 1988 we permitted a large three-storey extension to the rear of the Fallen Knight PH (88/0059/L) and a pair of houses to the rear of Kilwardby Mews (88/0143/P). This development does not contribute positively to significance. In the long term there is an opportunity to enhance character through the redevelopment of the site.

6.2. On the north side of Kilwardby Street [a] a non-conformist chapel and school were demolished c.1985 and replaced by an access drive. In 1988 we permitted a large three-storey extension to the rear of the Fallen Knight PH (88/0059/L) and a pair of houses to the rear of Kilwardby Mews (88/0143/P). This development does not contribute positively to significance. Replacement buildings should reflect the character of the 'Kilwardby Street east' character zone.

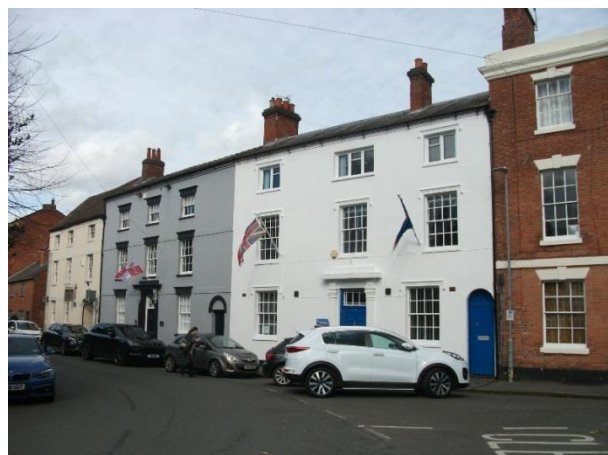
Lower Church Street

- 2.21.3. This character zone contains a diversity of uses. Generally buildings are arranged in terraced groups and laid out to the back of the pavement. Generally buildings are 2½ or 3 storeys tall. Generally buildings are faced in red brick. The character zone contains 13 listed buildings.

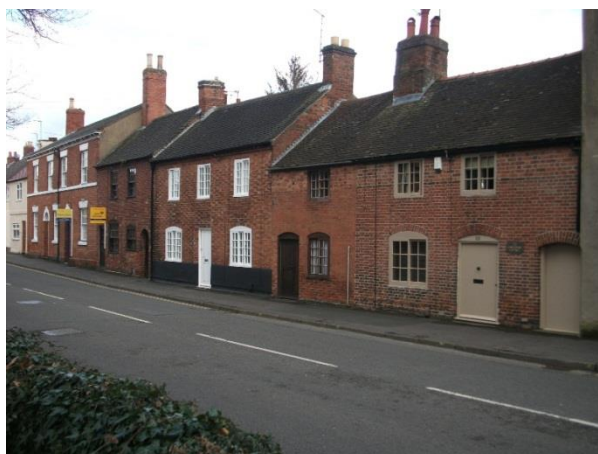
2.21.5. The 'Upper Church Street' character zone contains 7 listed buildings. The milestone outside 10 Wood Street is a grade II listed building.

2.21.6. 17 Wood Street was erected after 1923. It does not contribute positively to character; it does not reflect the layout of the character zone. In the long term there is an opportunity to enhance character through the replacement of the building.

6.6. 17 Wood Street [i] does not reflect the layout of the 'Wood Street west' character zone; it is set back behind a front garden. A replacement building should be laid out to the back of the pavement.

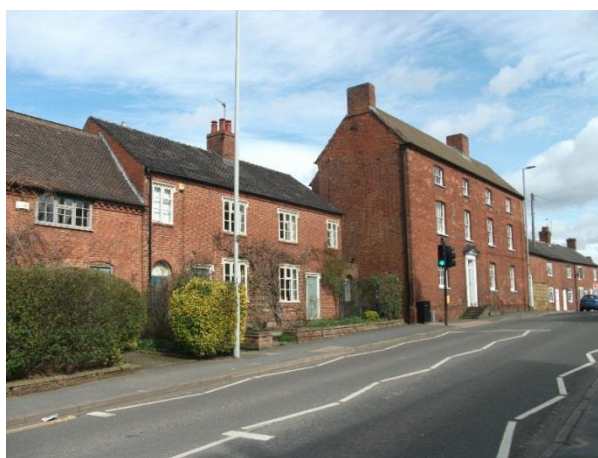
Wood Street east

2.21.7. This character zone is in residential use. Generally buildings are arranged in terraced groups and laid out to the back of the pavement; some courtyard development survives. Generally buildings are 2½ or 3 storeys tall. Generally buildings are faced in red brick. Non-traditional roofing materials intrude to a limited extent but note their impact upon the terrace 56 to 62 Wood Street. The character zone contains 9 listed buildings.

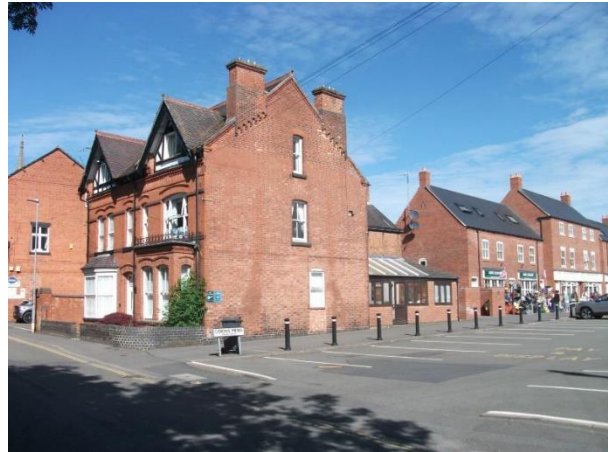
2.22.1. This character zone is in residential use. It contains a mixture of detached, semi-detached and terraced buildings laid out behind shallow forecourts. It contains a diversity of building heights. Generally buildings are faced in red brick. Generally roofs are covered with natural slate but note the use of concrete tile at 'Loudoun Court'. 'Ivanhoe Terrace' is a grade II listed building.

2.22.2. To the west of the former Police Station, a short terrace was demolished after 1923. The terrace was replaced by a surface car park that does not contribute positively to character. In the long term there is an opportunity to enhance character through the redevelopment of the site.

- j) **South Street west:** A building was demolished after 1923 and replaced by a surface car park. A replacement building should reflect the character of the South Street west character zone.

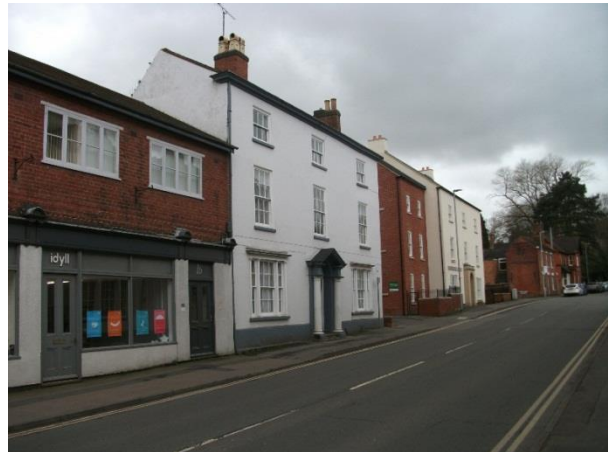
2.22.4. This character zone contains a diversity of uses. Generally buildings are arranged irregularly. The zone contains a diversity of building heights and facing materials. The Church of the Holy Trinity and Hendon House are grade II listed.

2.22.5. To the west of the 'Old Bank', buildings were demolished after 1923. The buildings were replaced by a surface car park that does not contribute positively to character. In the long term there is an opportunity to enhance character through the redevelopment of the site. In 2017 the District Council permitted the erection of a three-storey building containing a mix of uses (our reference 17/00430/FUL).

- k) **Kilwardby Street south:** Buildings were demolished after 1923 and replaced by a surface car park. Replacement buildings should reflect the character of the Kilwardby Street south character zone. In 2017 the District Council permitted the erection of a three-storey building containing a mix of uses (our reference 17/00430/FUL).

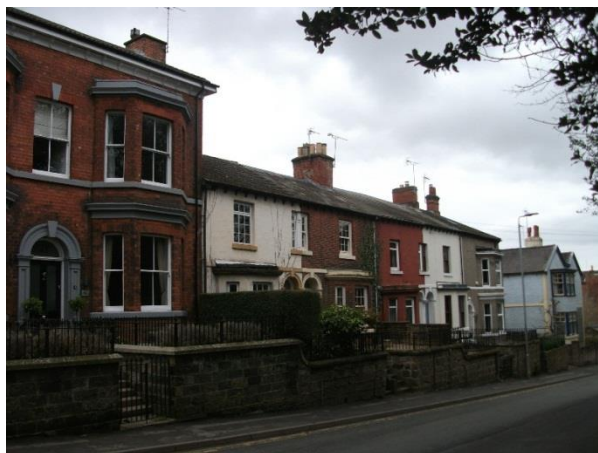
Kilwardby Street west

2.22.8. This character zone is in residential use. It contains high status development from the early Victorian period. It contains a mixture of detached, semi-detached and terraced houses laid out behind shallow forecourts. Generally buildings are two storeys tall. The zone contains a diversity of building heights and facing materials. Non-traditional roofing materials intrude to a limited extent but note their impact upon 'Shrubbery Terrace'. 26 and 26A Kilwardby Street are grade II* listed.

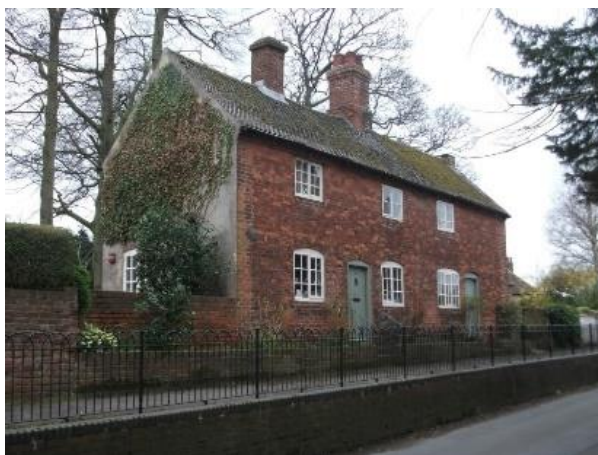
2.22.11. This character zone is in residential use. It contains high status development from the early Victorian period. Generally buildings are laid out irregularly. Garden land at 2 to 4 Hill Street contributes positively to character. Garden land at 4 Hill Street contains mature trees. Generally buildings are 1½ or 2 storeys tall.

2.22.12. Generally buildings are faced in red brick beneath plain tile roofs. 1 Hill Street was erected after c.1700 but retains "earlier features". It is faced in render, with elements of timber framing and rubble stone, beneath a thatched roof. 1 and 3 Hill Street are grade II listed buildings; curtilage structures associated with 'Larach Beag' are also grade II listed.

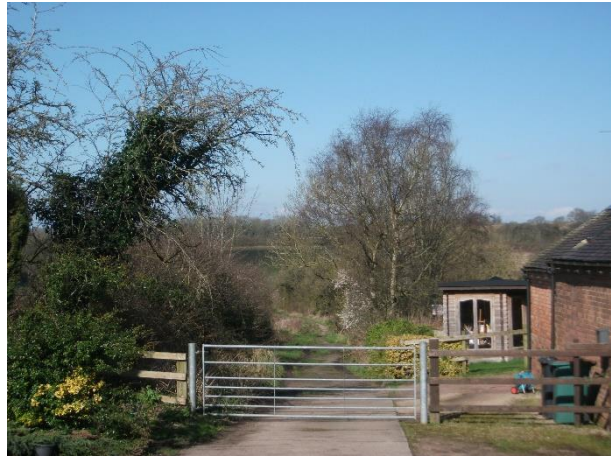
- 3.6. The access drive between 55 and 57 Wood Street offers a glimpse into countryside (pictured). This glimpse illustrates the historic relationship between the settlement core and the surrounding countryside. The District Council has permitted the erection of 605 dwellings on land at Money Hill (15/00512/OUTM). The master plan indicates that the access drive would be retained as a “pedestrian link” bounded by hedges.

4.5. The access drive between 55 and 57 Wood Street offers a glimpse into countryside. This glimpse illustrates the historic relationship between the settlement core and the surrounding countryside. The District Council has permitted the erection of 605 dwellings on land at Money Hill (15/00512/OUTM). The master plan indicates that the access drive would be retained as a "pedestrian link" bounded by hedges.

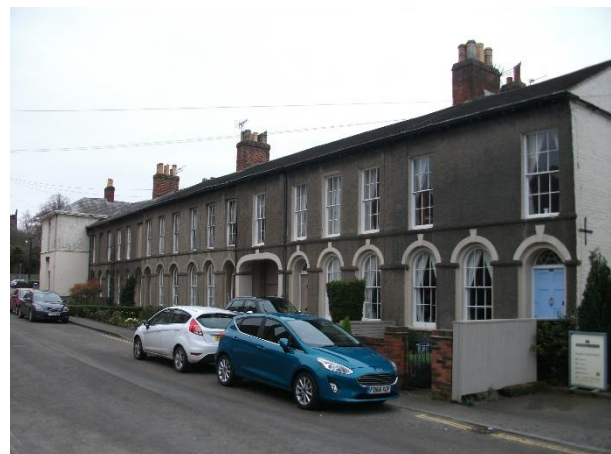
- p) Surface car park etc.: A surface car park and detached house laid out c.1923-71;
- q) ‘Priest House’ and 18 to 23 South Street: A detached house and a terrace (pictured) erected in the early or mid-nineteenth century;
- r) Telephone exchange etc.: A telephone exchange¹¹ erected c.1962 and four detached houses erected c.1923-71.

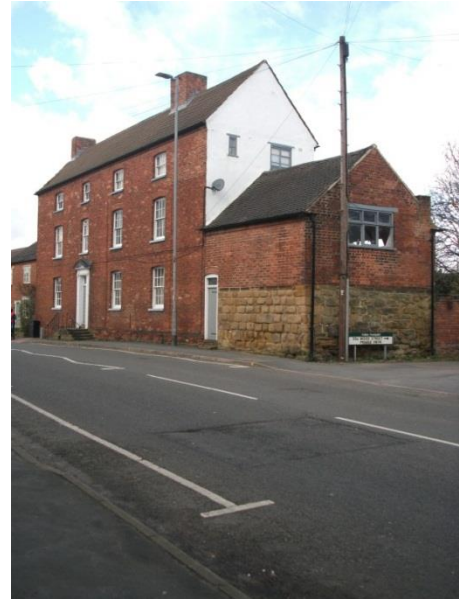
4.4. 55 Wood Street (pictured right) is a prominent feature at an 'entrance' to the conservation area. The building is situated at the brow of a hill. It is three storeys tall and laid out to the back of the pavement; adjacent buildings are two storeys tall and laid out behind shallow forecourts.

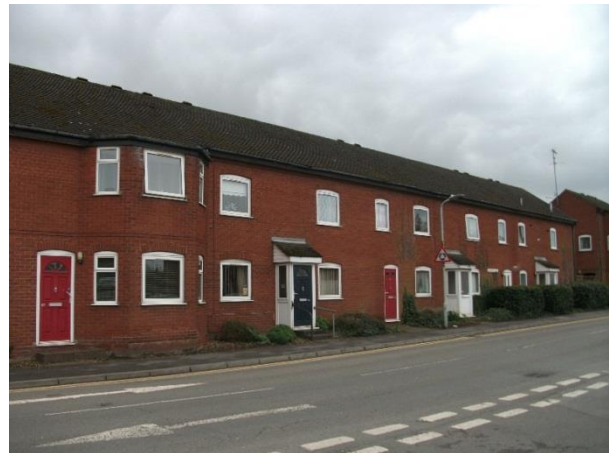
Claridge Place

5.1. Properties including a 'coal yard' were demolished c.1978-81 and replaced by 28 flats. The flats are laid out behind shallow forecourts and introduce soft landscaping in a manner that does not reflect the 'Green' character zone. The flats are arranged in large blocks with unbroken eaves and ridge lines; they do not reflect the diverse height and massing of buildings in the 'Green' character zone.

5.2. 5A Brook Street was erected in 1979 (our ref 79/0672/R). It is subservient in scale to the principal building (5 Brook Street) but it does not reflect the height of buildings in adjoining character zones.

- 5.3. In the long term there is an opportunity to enhance character through the replacement of these buildings. The replacement buildings should reflect the layout of the 'Green' character zone. They should reflect the diverse height and massing of buildings in that character zone.

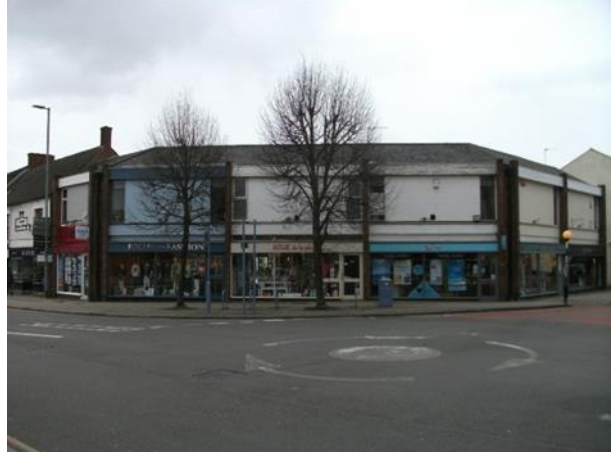
Derby Road

- 5.4. Properties were demolished c.1906 for the Burton & Ashby light railway; public conveniences were erected c.1923-48. Further properties were demolished piecemeal after 1948 and replaced by shops.

- 5.5. The public conveniences are laid out behind a shallow forecourt and they introduce soft landscaping in a manner that does not reflect adjoining character zones. They do not reflect the height of buildings in adjoining character zones. Land at the Shoulder of Mutton PH makes a neutral contribution to character but 'hoop top' railings are uncharacteristic.

- 5.6. 'Bath Street Corner' does not reflect the massing and materials of buildings in adjoining character zones. It is a 'cross wall' structure with a shallow pitched roof. 11 Market Street makes a neutral contribution to character but the previous character appraisal notes the "extensive blank façade" addressing Derby Road.

- 5.7. In the long term there is an opportunity to enhance character through the replacement of these buildings. The replacement buildings should reflect the character of the adjoining 'Bath Street' and 'Market Street west' character zones. They should be laid out to the back of the pavement; the opportunity to recreate the historic street layout should be explored. They should be faced in red brick. They should offer active frontages to each street elevation.

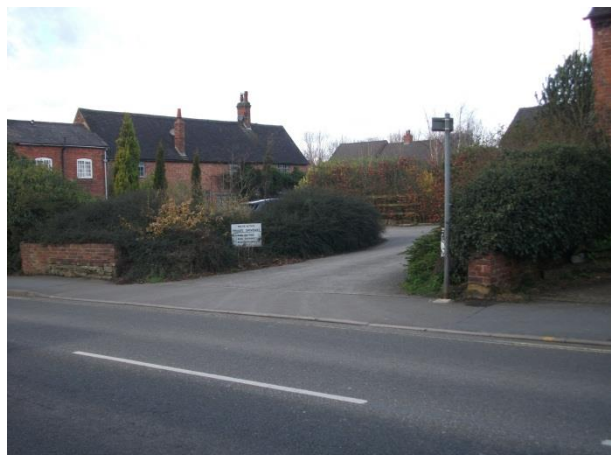
The Farm

- 5.8. Properties were demolished c.1948-71. The site contains a large amount of soft landscaping that does not reflect adjoining character zones. The soft landscaping is dominated by cotoneaster and laurel while 47 & 49 Wood Street is bounded by a privet hedge. In the long term there is an opportunity to enhance character through the redevelopment of the site.

- 5.9. New buildings should reflect the adjoining 'Upper Church Street' and 'Wood Street east' character zones. New buildings should be laid out to the back of the pavement; they may reflect traditional courtyard development. They should be faced in red brick. They should reflect the diverse heights of buildings in the adjoining character zones. Redevelopment would offer an opportunity for the investigation of below-ground remains.

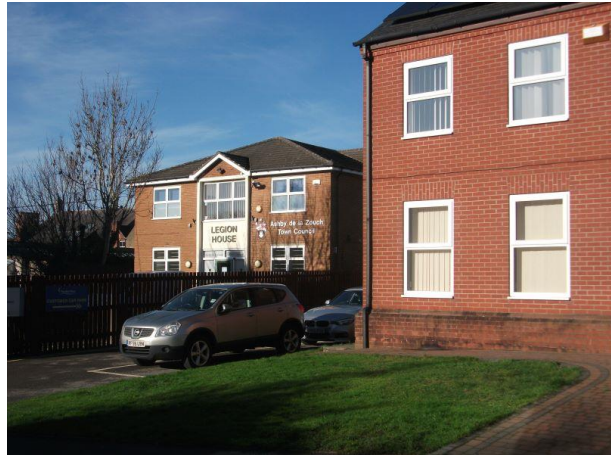
South Street east

- 5.10. Properties were demolished c.1948-71; a club (now 'Legion House') opened in 1966. Legion House does not reflect the layout, massing or materials of adjoining character zones. Its layout does not reflect traditional court development. It has a shallow pitched roof, a deep roof span and a complex roof shape. It is faced in brown brick with a non-traditional roof covering.

- 5.11. To the rear of 76 Market Street, single-storey flat-roofed garages do not reflect the scale and massing of adjoining character zones. To the rear of 92 Market Street, a large flat-roofed building does not reflect the scale and massing of adjoining character zones. 'Castle Flats' and 'Castle House' make a neutral contribution to character.
- 5.12. In the long term there is an opportunity to enhance character through the redevelopment of the site. New buildings should reflect the adjoining 'Market Street east' and 'Lower Church Street' character zones. They should be laid out to the back of the pavement; they may reflect traditional courtyard development. They should be faced in red brick. They should be 2½ or 3 storeys tall.
- 5.13. 26 & 27 South Street were erected before 1884. This building contributes positively to character.

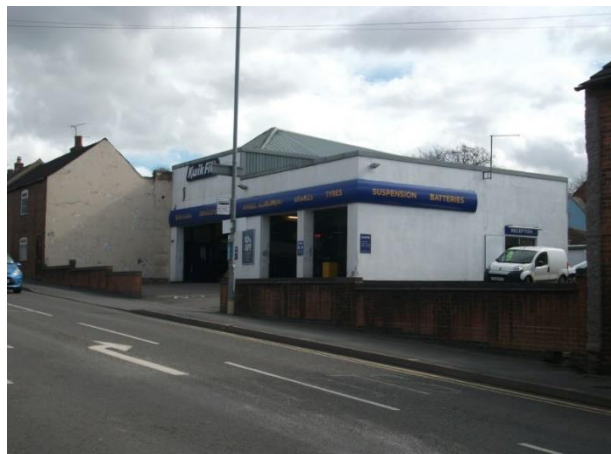
Wood Street central

- 5.14. On the north side of the street, 29 Wood Street was demolished and replaced c.1948-71 by a 'depot'. On the south side of the street, a garage was erected c.1923-48. 16 to 20 Wood Street were demolished in 1960. In all respects the development does not reflect adjoining character zones.

- 5.15. In the long term there is an opportunity to enhance character through the replacement of these buildings. The replacement buildings should reflect the character of the adjoining 'Upper Church Street' and 'Wood Street west' character zones. They should be laid out to the back of the pavement; they may reflect traditional courtyard development. They should be faced in red brick. They should be 1½ or 2 storeys tall.

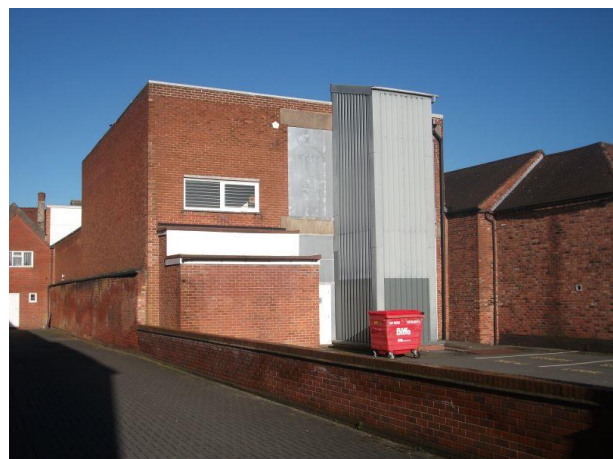
c) **12 & 14 Market Street:** The building does not reflect the massing and materials of the character zone. A shallow pitched roof addresses Market Street and a flat roof addresses South Street. The rear elevation contains non-traditional facing materials (pictured right).

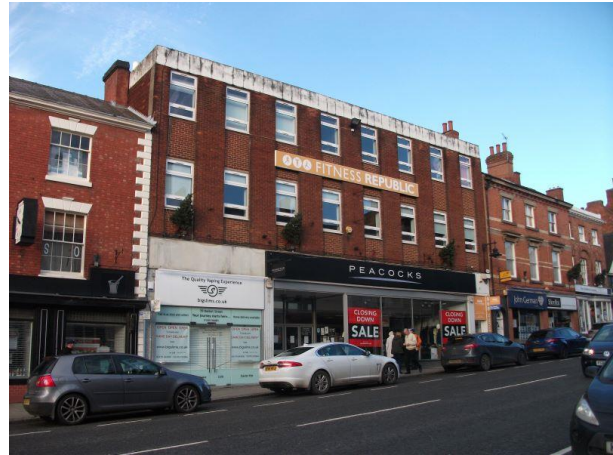
- g) **57 & 59 Market Street:** This large building does not reflect the scale and massing of the character zone (pictured). It is 'double width' (i.e. it occupies two traditional plots) and it is more than three storeys tall. It has a flat roof.

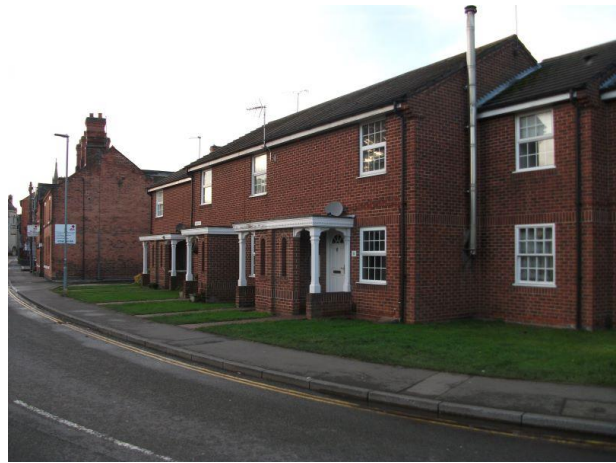
6.9. Front gardens at ‘Ivanhoe Terrace’ contribute positively to character. Gardens are bounded by a mix of palisade railings and privet hedges. ‘Loudoun Court’ offers an opportunity to enhance character through the introduction of similar boundaries.

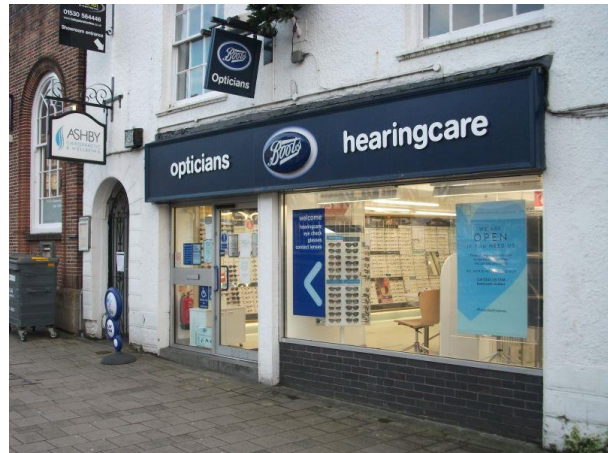
- Two listed buildings contain untreated aluminium shop fronts (52 Market Street (pictured); 63 Market Street).

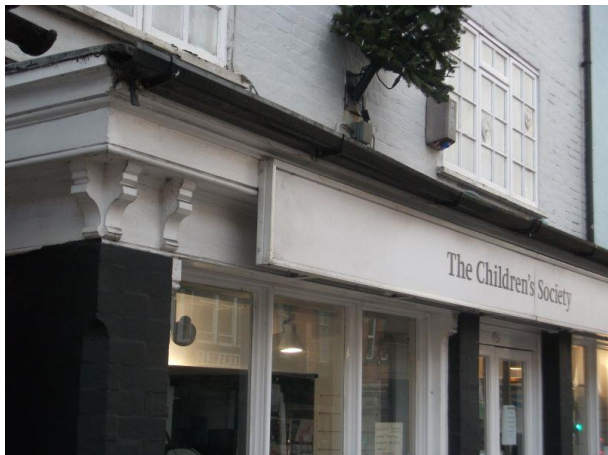
- The terraced group 15 to 33 Market Street contains several large fasciae. 33 Market Street has a very large fascia that extends over the first floor window sills.
- At 94 and 96 Market Street fascia signs have been installed in a manner that obscures the frieze and cornice (pictured below). At 50 and 84 Market Street panel signs have been attached to buildings “where there is no fascia”.
- Lettering should be painted directly onto the shop front rather than on a board which is then stuck on; 72 Market Street is an example of bad practice.
- Three listed buildings feature swan neck lights; all are hot foot takeaways (77 Market Street; 85 & 85A Market Street; 88 Market Street).

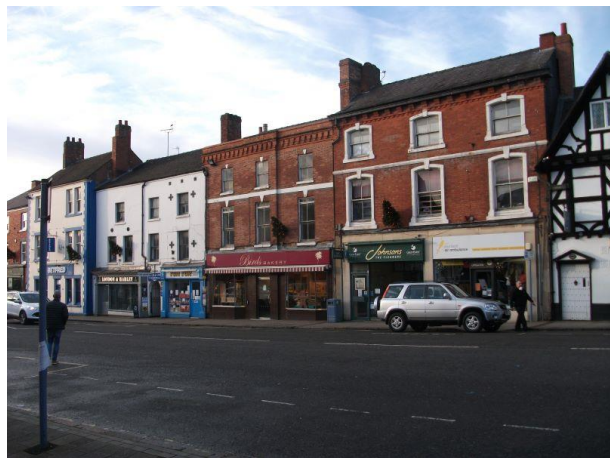
- Three listed buildings in the 'Market Street west' character zone were found to be vulnerable (20 Market Street; 47 Market Street; 50 Market Street). The terraced group 43 to 49A Market Street (pictured right) was found to be in fair condition¹⁵.
- The former Fallen Knight Hotel and 16 and 18 Kilwardby Street were found to be vulnerable. In 2019 the District Council permitted alterations to the buildings to form three 'town houses' and eight apartments (our reference 18/00286/FULM).

¹⁵ In April 2021 the local planning authority refused to grant planning permission for the demolition of an outbuilding at 49 Market Street but acknowledged that there was "clear and convincing justification for immediate remedial works" (21/00373/FUL).
